Service Bulletin SB-0025

Subject: Wire Routing Improvements

ATA-Code: 24-00

Affected Model(s): E1000, E1000 GX

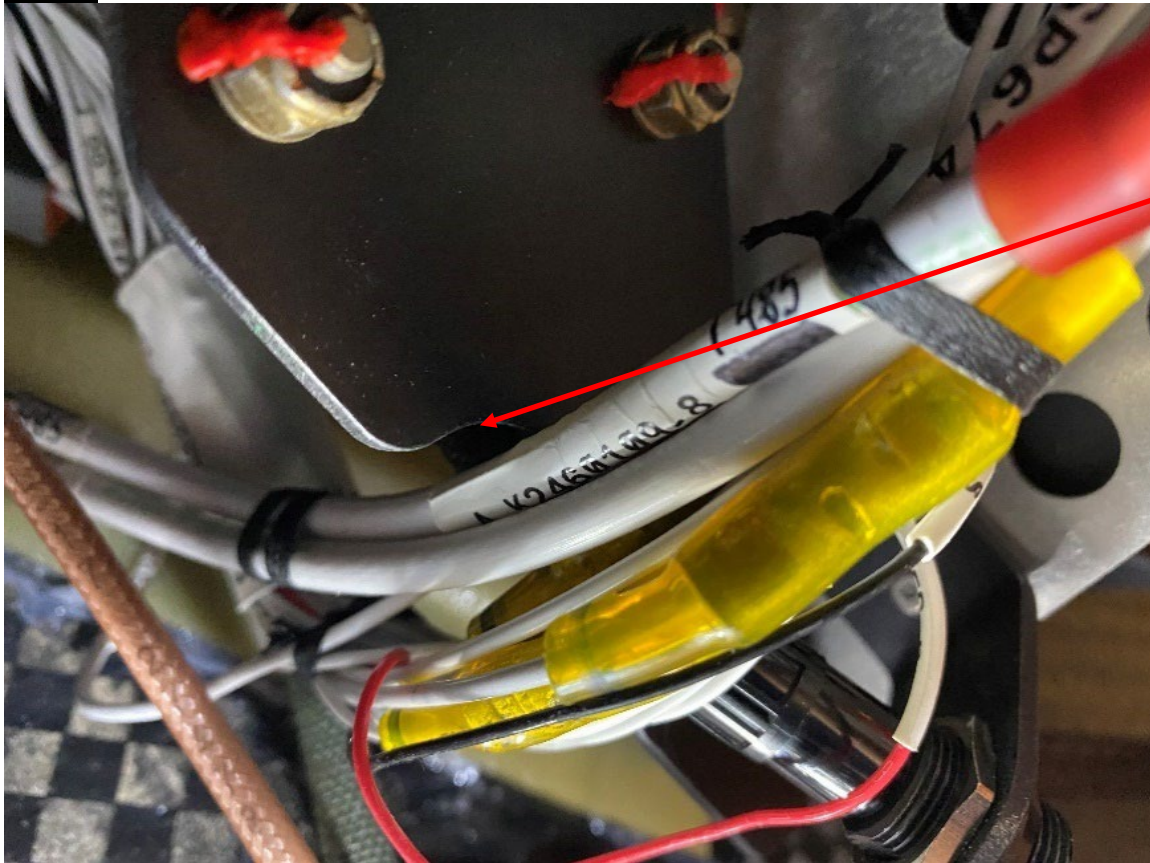
Before:

Location: Left and right circuit breaker panels (Removed from Aircraft).

Chafe hazard.

Action: Add Roundit to exposed bare wires; Add edge protection to sharp metal edges to protect wire(s) to prevent chafing.

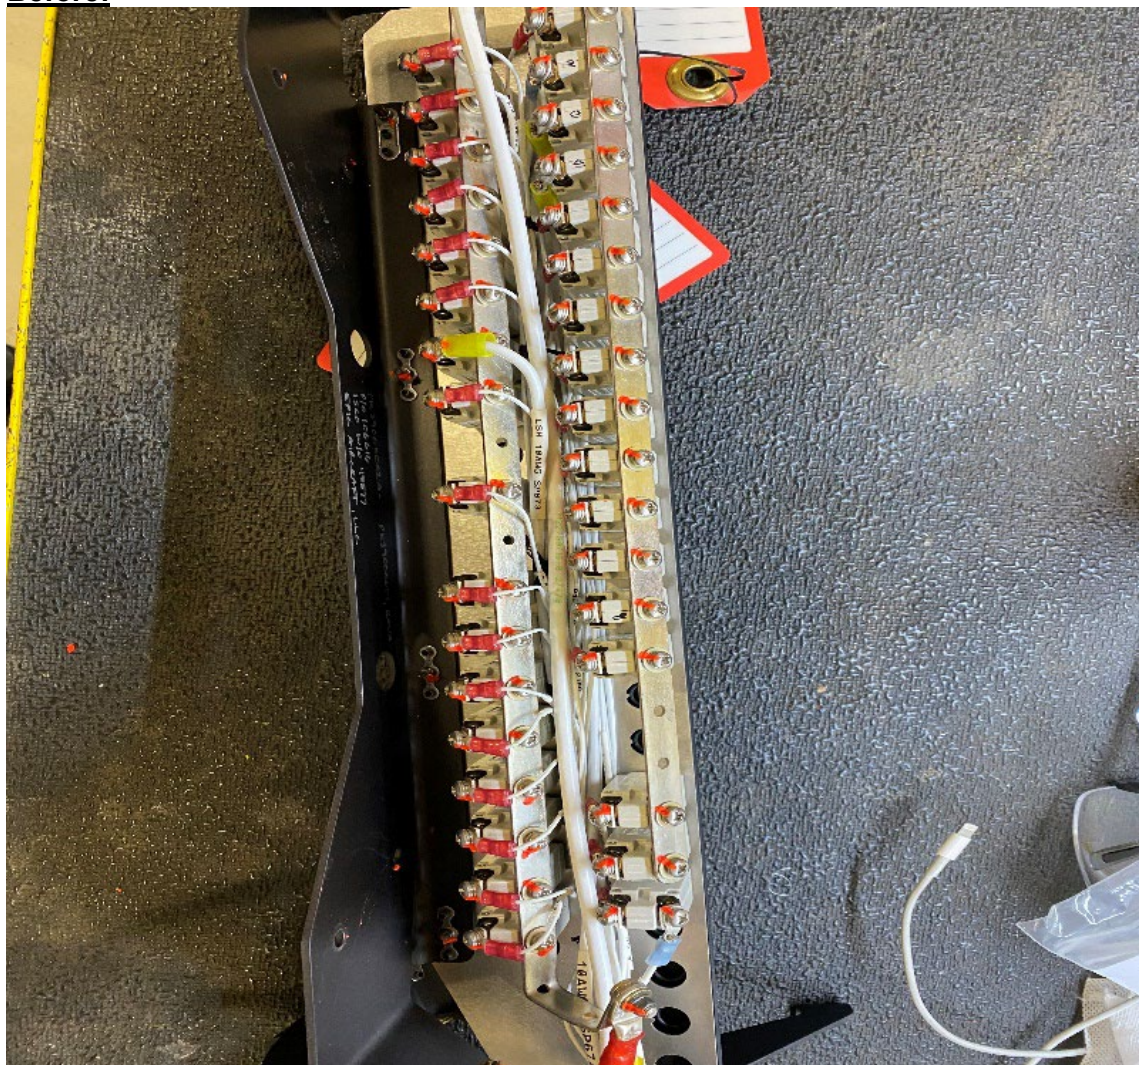
Before:

Location: Left and Right Circuit Breaker Panels (Removed from Aircraft).

Action: Bundle loose wires using tie string in several locations.

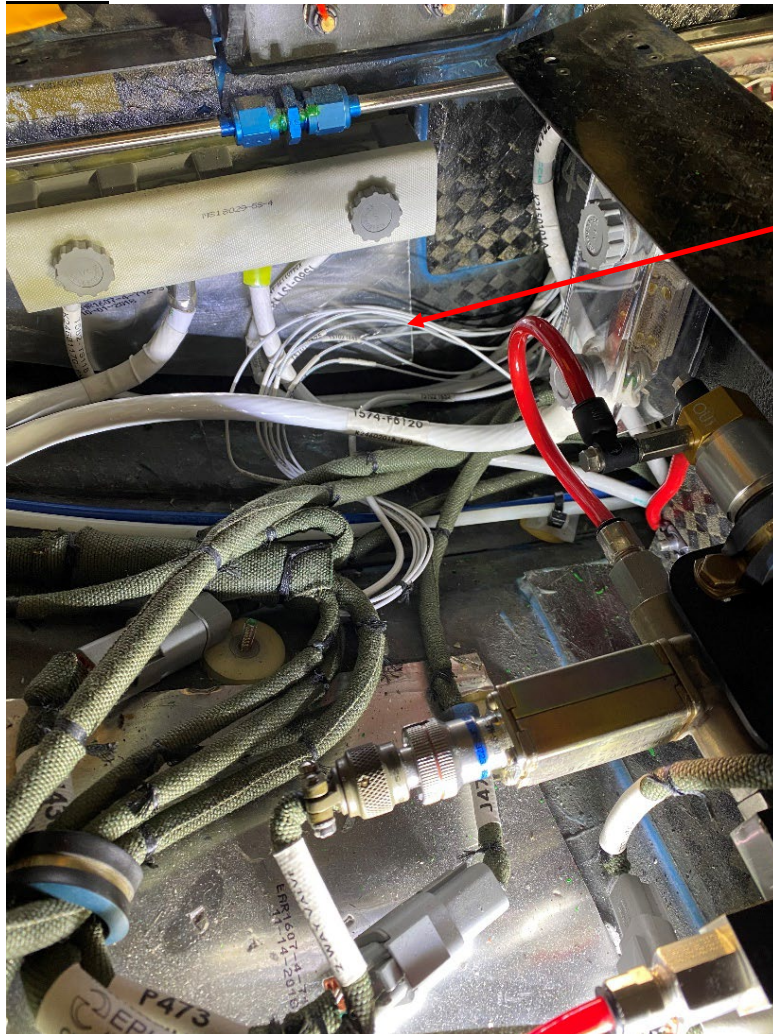
Before:

Loose ground wires.

Action: Bundle and install chafe protection on loose ground wires going to ground block TS101 & TS102.

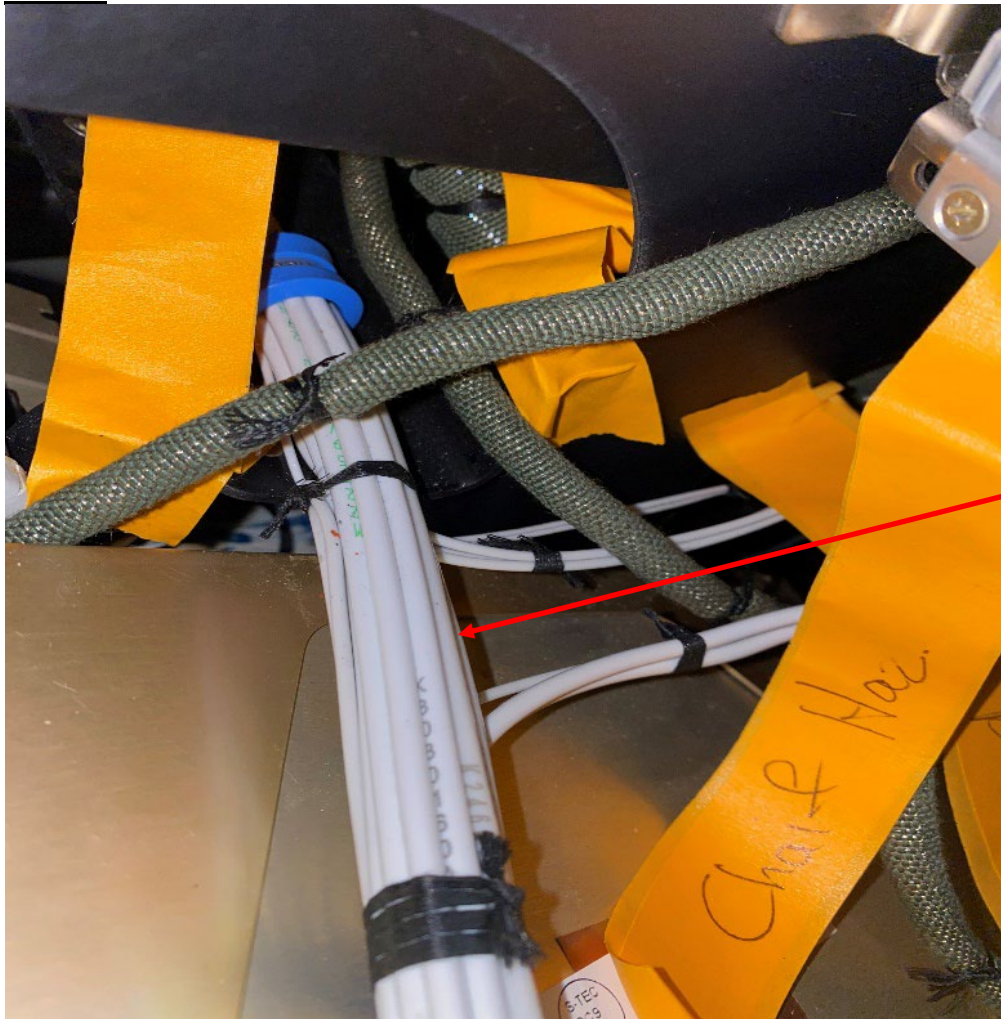
Before:

Exposed harness.

Action: Wires in the forward trough, behind both PFD's & MFD, along the front of the instrument panel, need Roundit on the 10 AWG harnesses and surrounding wires.

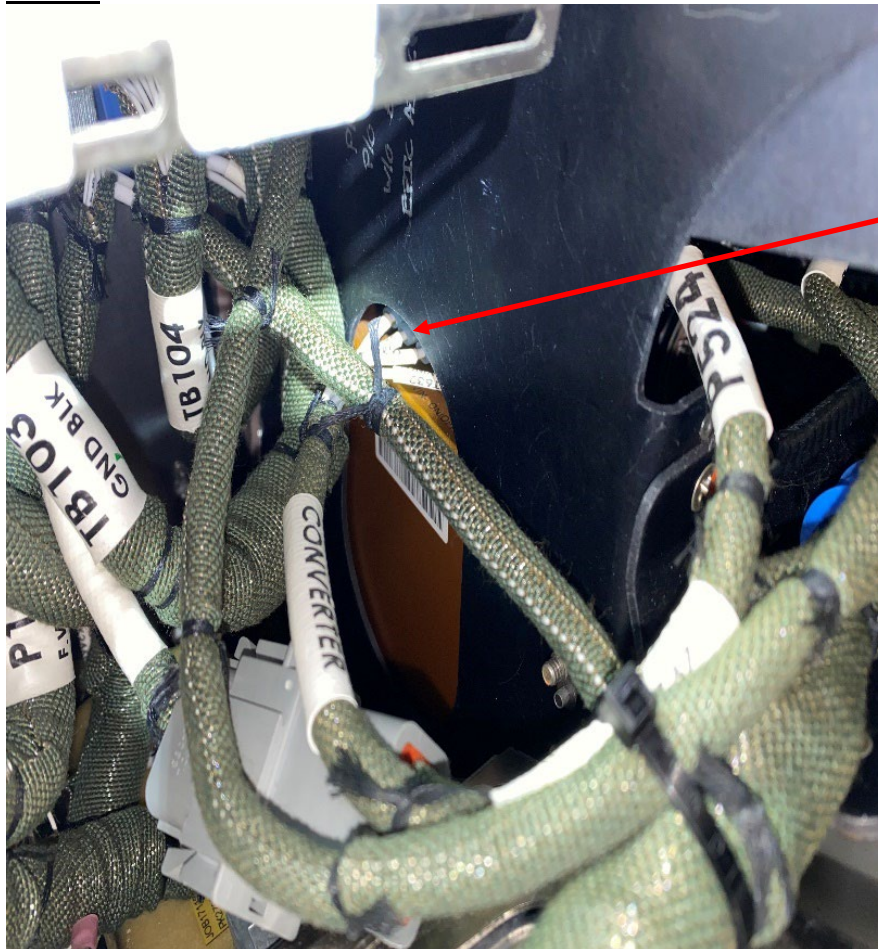
Before:

Chafe hazard.

Action: Add edge protection on the exposed metal edges where harness crossed over to the converter.

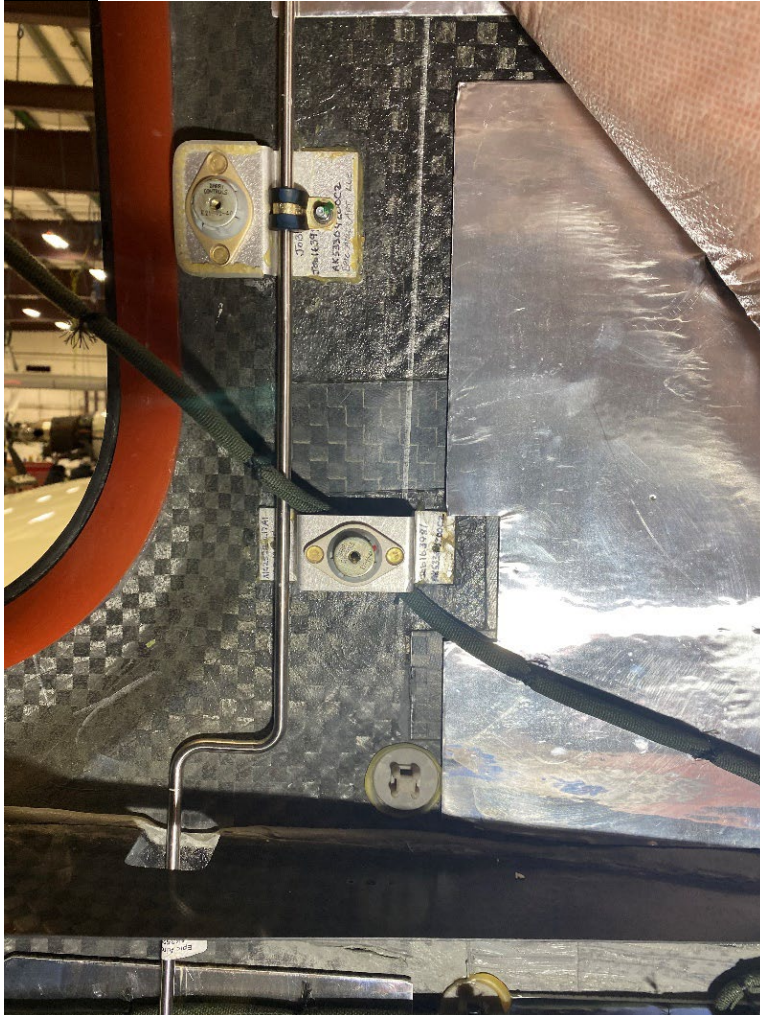
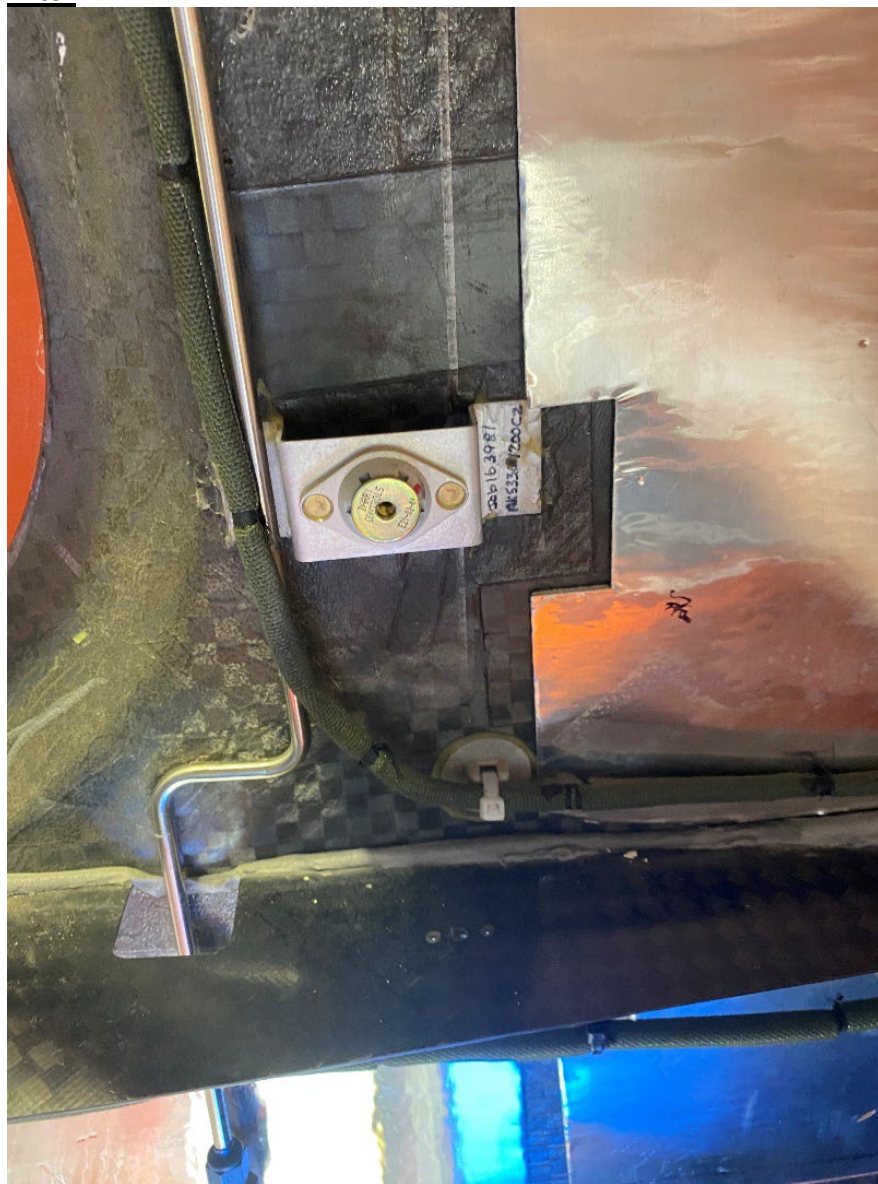
Location: Cabin Windows – Harnesses routed near stand-offs.

Action: Use tie mounts for window harness; DO NOT use sidewall panel stand-offs for routing/securing. Re-route wire harness to intended tie mount.

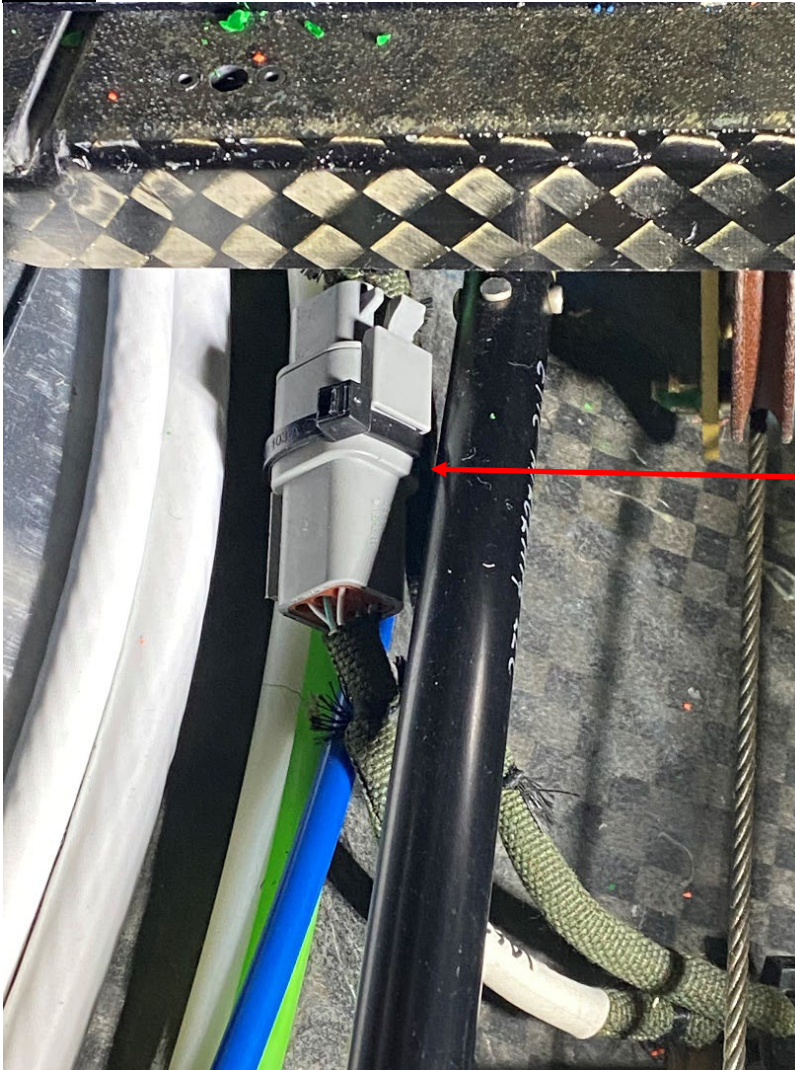
Before:

Contact with linkage.

Action: Secure connector under pilot's floorboard away from moving linkage using a tie mount as shown.

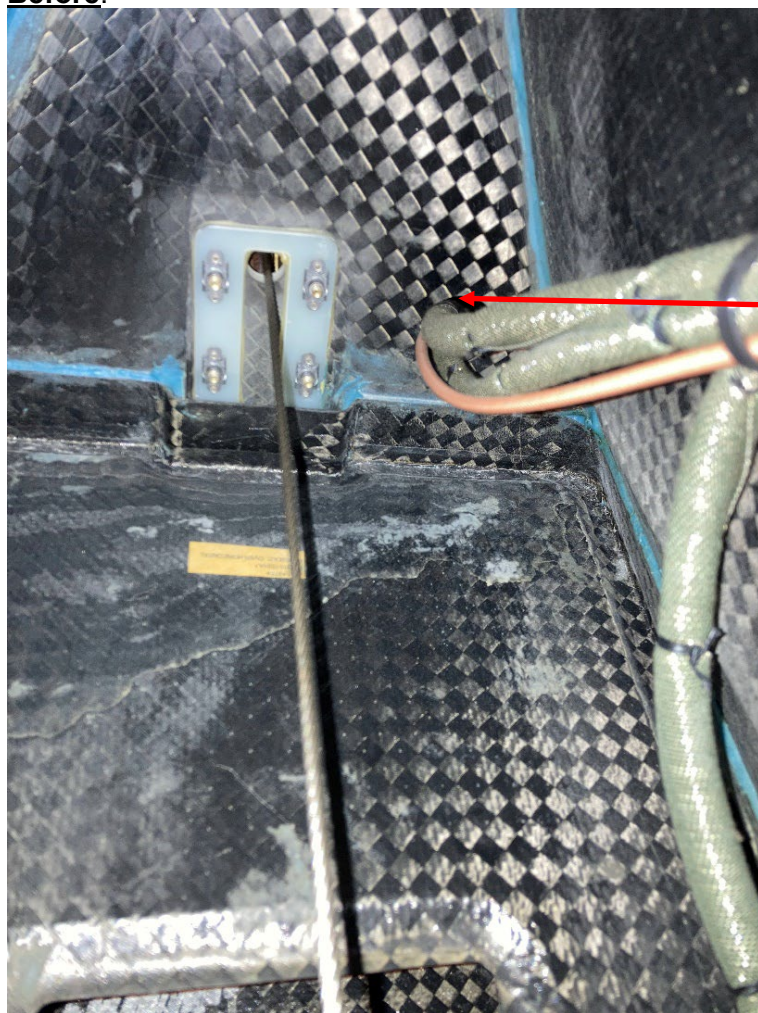
Before:

Chafe hazard.

Action: Install edge protection at the pass-through hole.

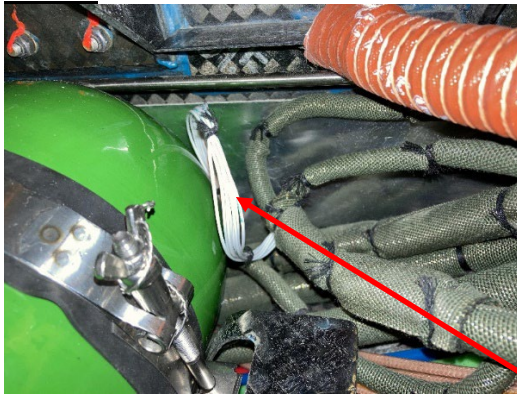
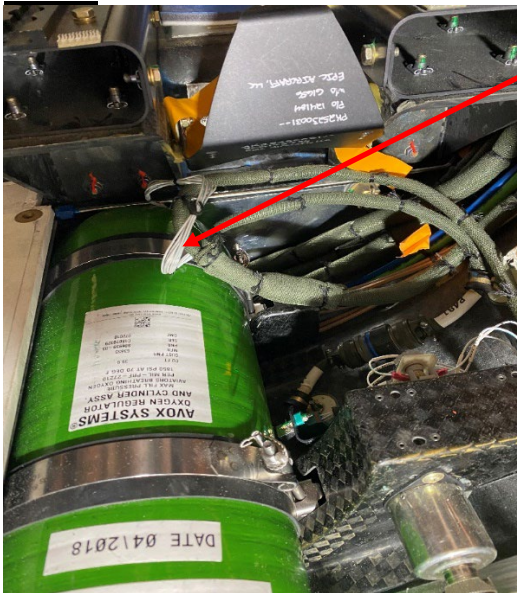
Ground wires.

Action: Install Roundit on ground wire bundle up to the TS101/102 ground block.

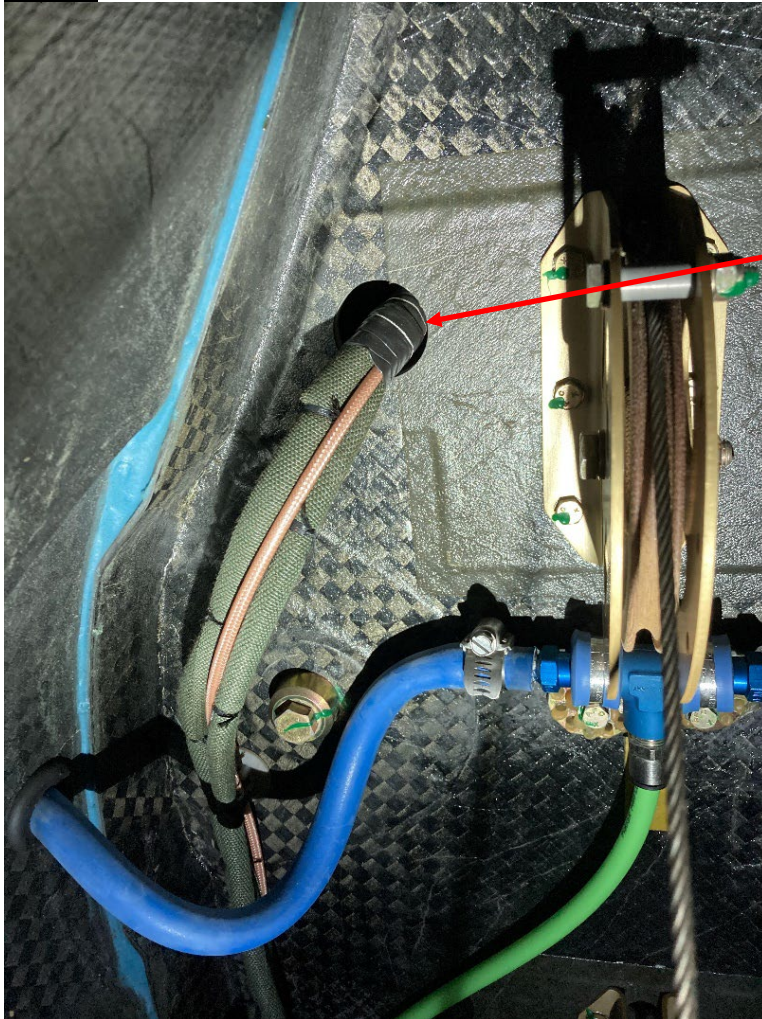
Before:

Chafe hazard.

Action: Install edge protection at the pass-through hole.

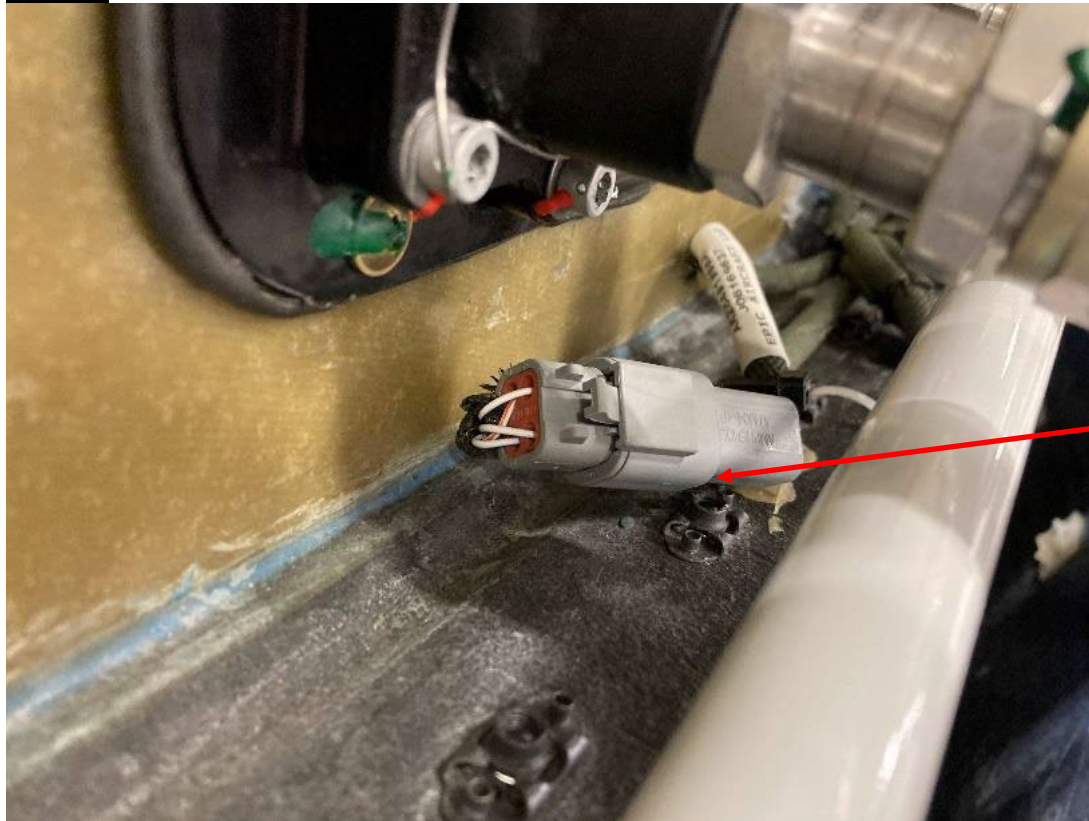
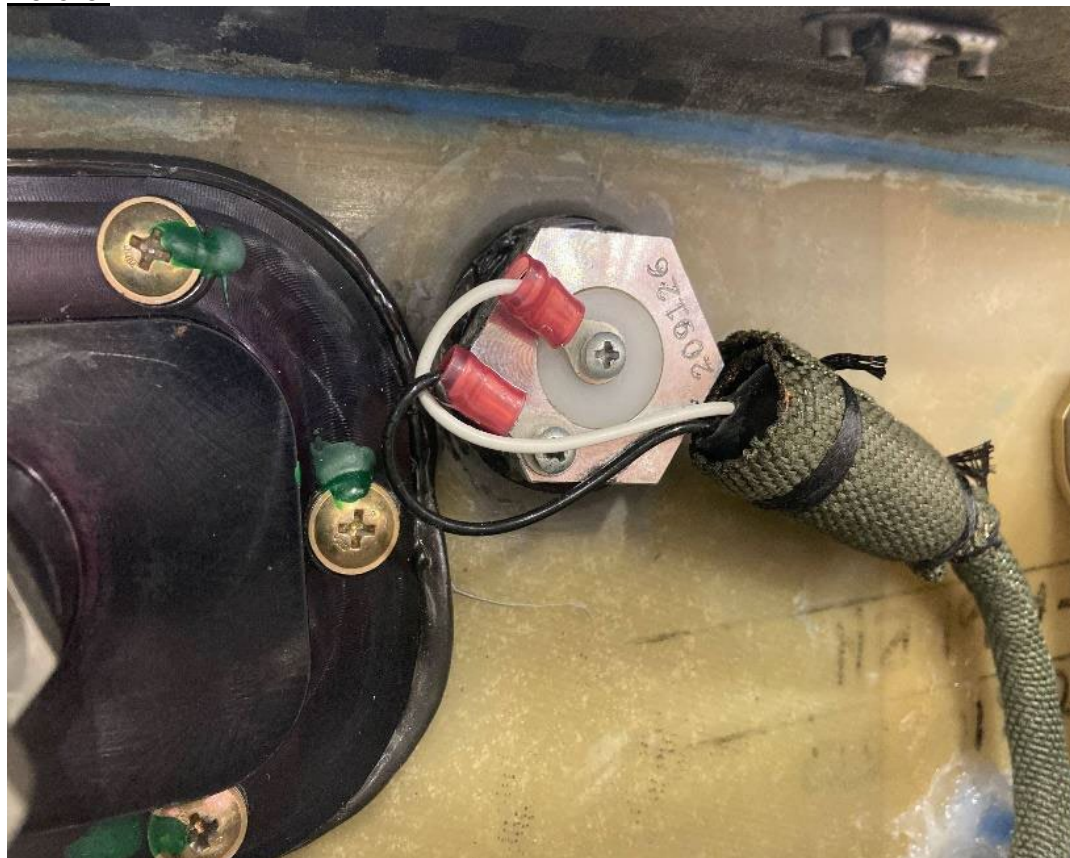
Chafing hazard.

Action: Install tie mount to prevent the harness and connector from contacting the nutplates. Re-clock the terminals on the fuel probe and install tie mount to secure the harness on the wing rib.

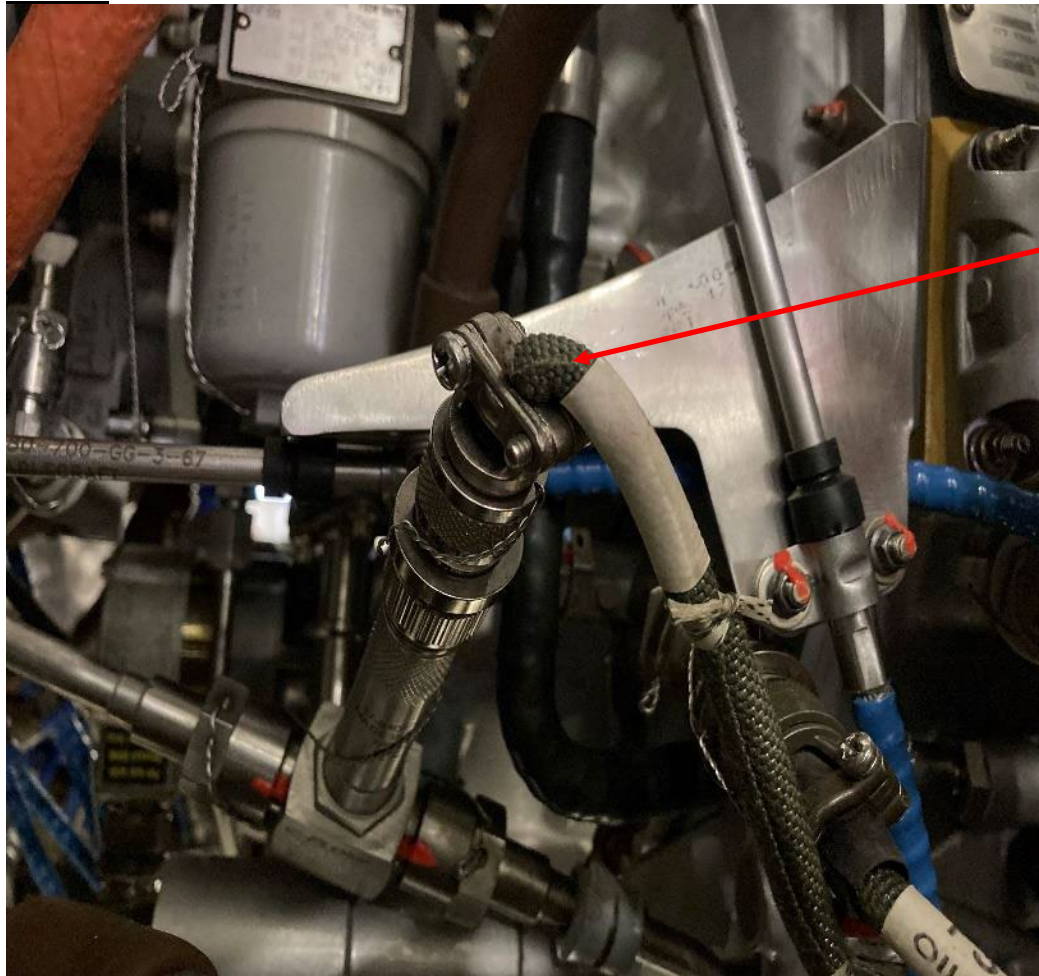
Before:

Excessive
bend.

Action: Re-rout harness as shown to relax tight bend.

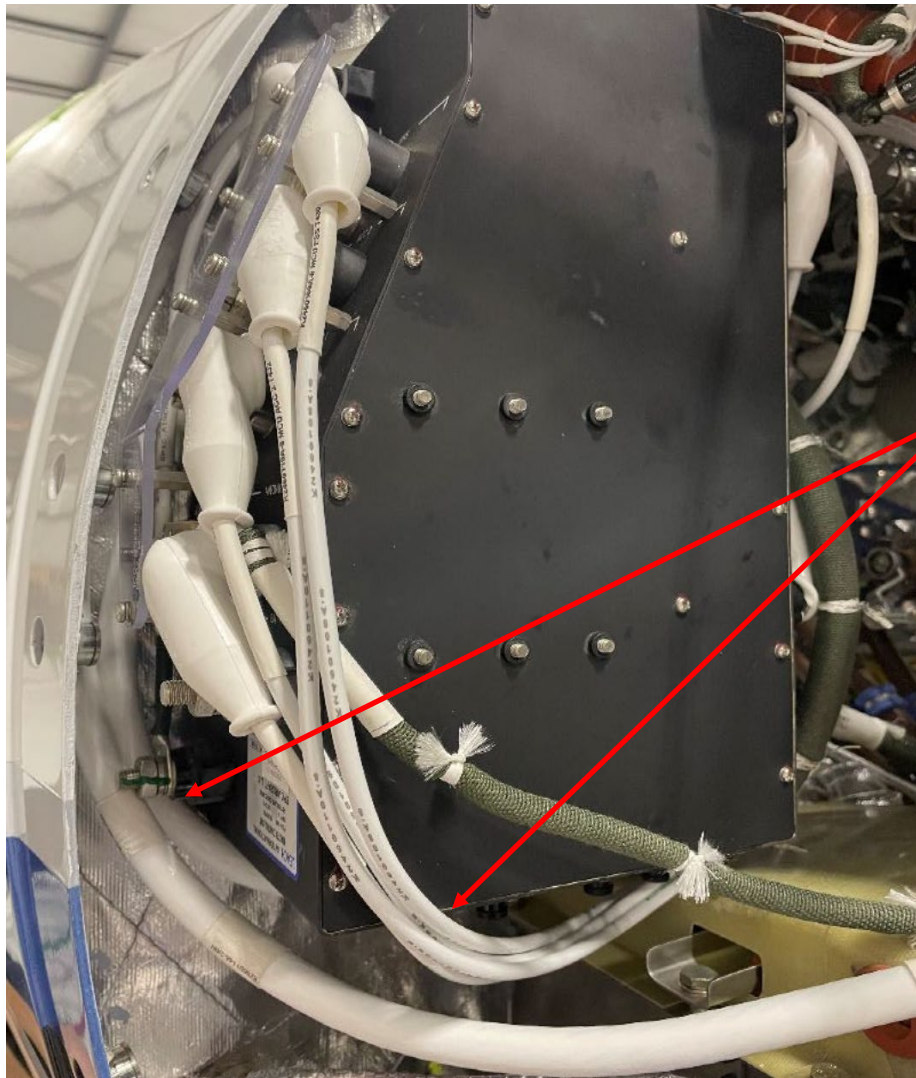
Before:

Chafe hazard.

Action: Install Roundit on power wires to prevent damage from MCU case and ground stud.

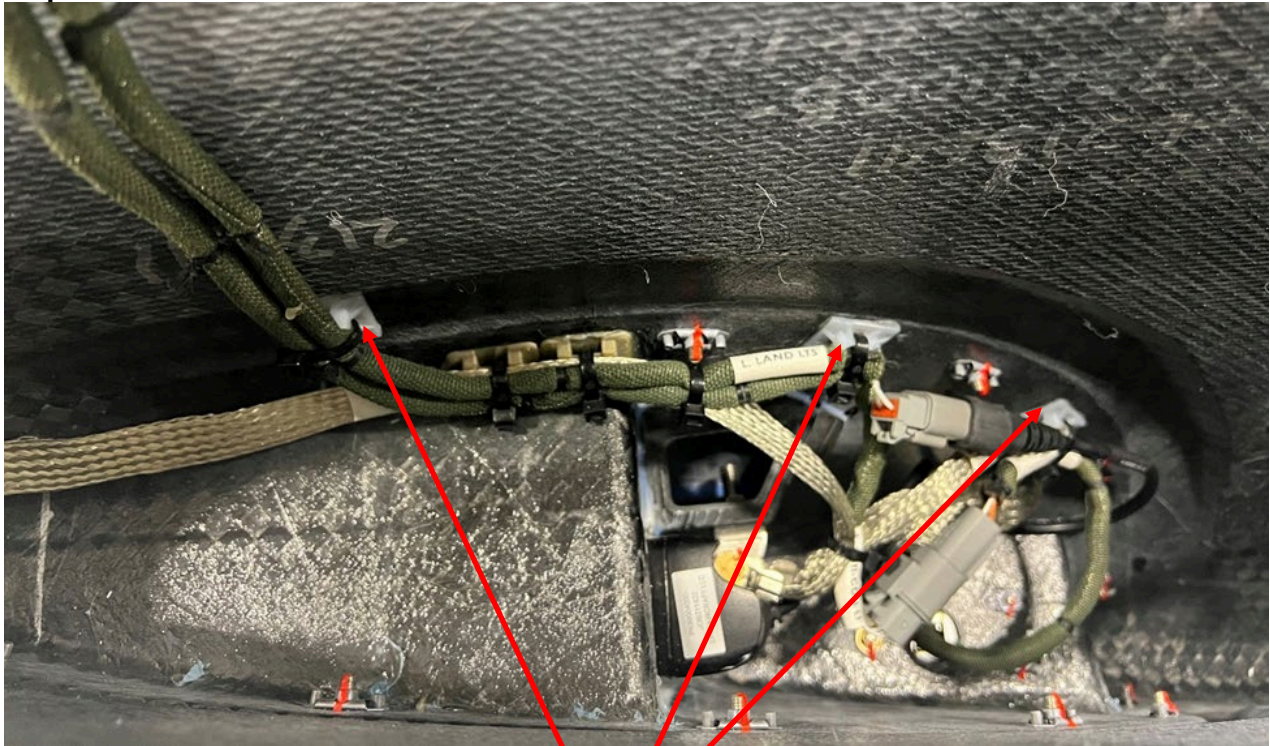
Inspect:

Zip Tie Mounts

Action: Make sure all zip tie mounts for the landing/anti-collision light harnesses are securely bonded to the wing tip. Re-bond if needed.
