Service Bulletin SB-0026

Subject: Firewall Blanket Inspection

Affected Model(s): E1000, E1000 GX

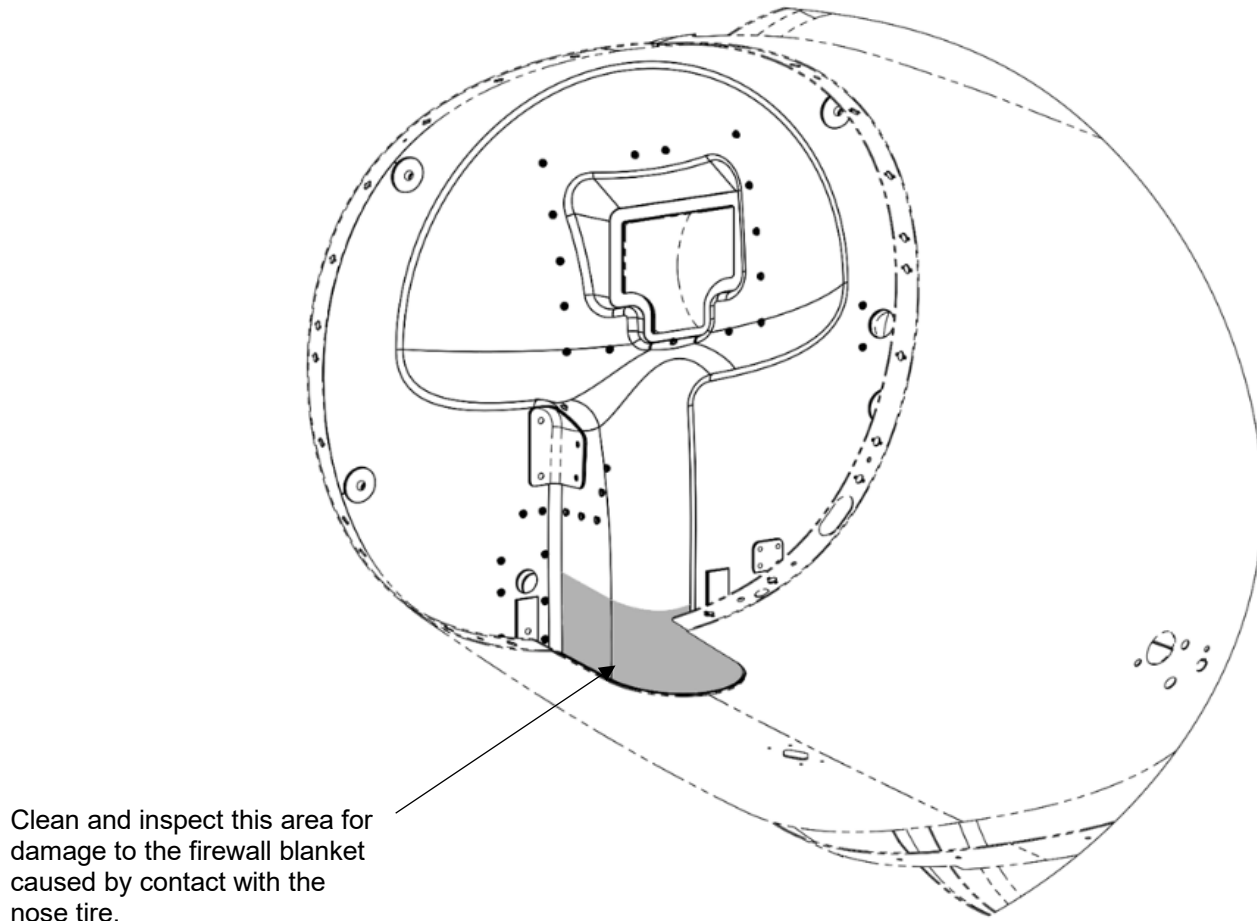
Figure 1: Firewall Blanket Inspection

It has been found the firewall blanket fit may be allowing the nose landing gear wheel and/or tire to contact it when retracted.

3. Clean the firewall blanket with isopropyl alcohol and inspect it for damage. Make sure to clean any areas that appear to have had contact with the nose wheel or tire. It is acceptable for the aluminized coating to be missing. Contact Epic Aircraft if any tears through the blanket are found, refer to Figure 1.

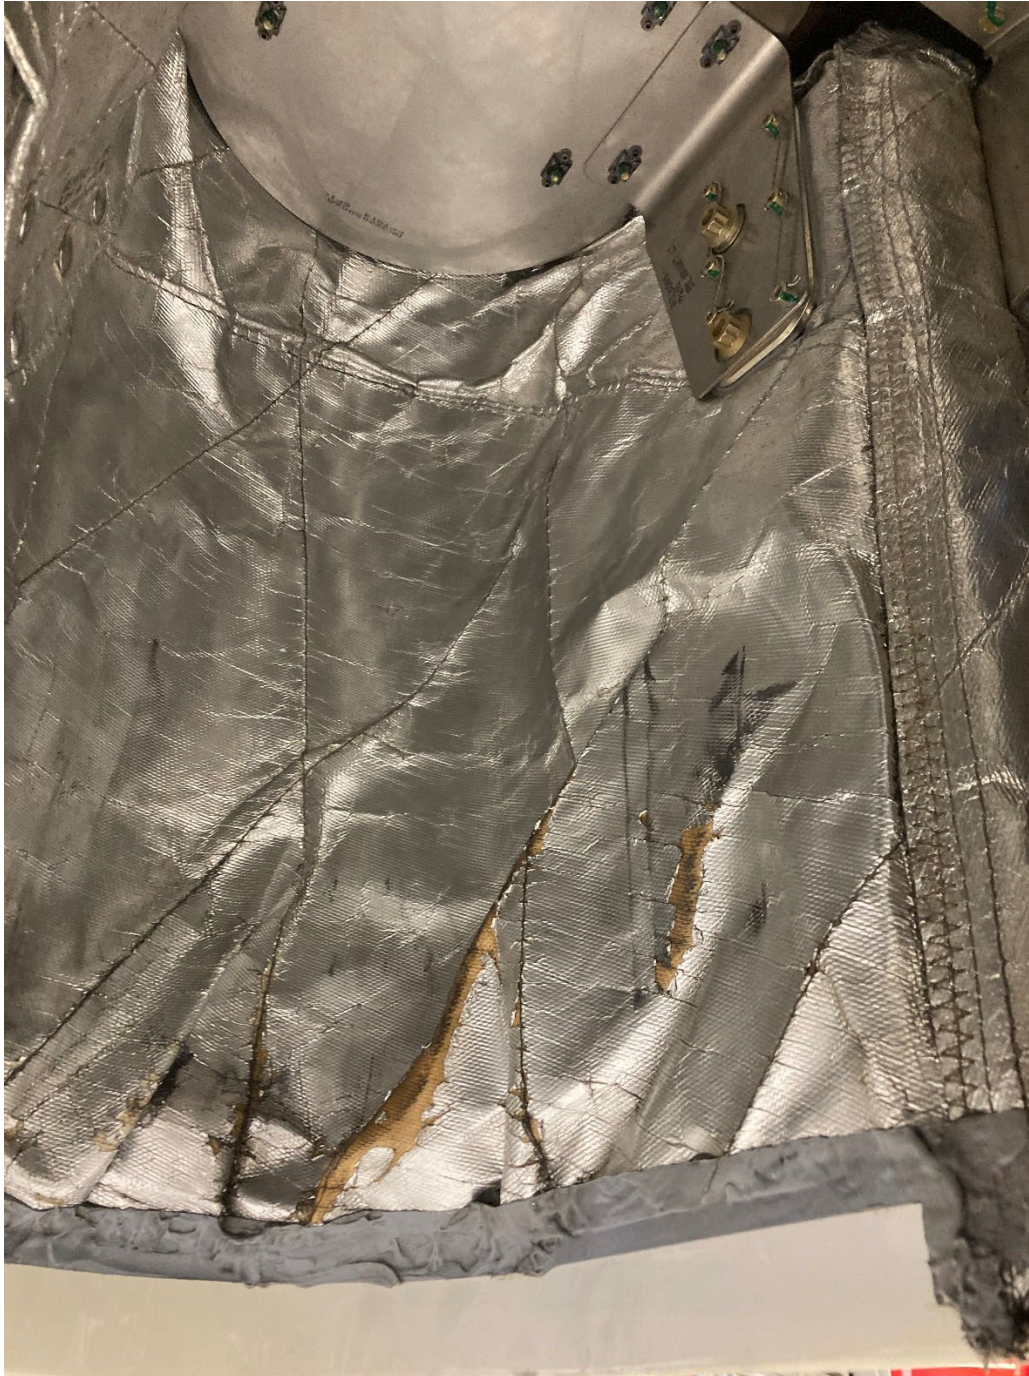
Figure 2: Firewall Blanket Inspection – View Left Side

NOTE: Refer to figure 2-4 for examples of acceptable wear.
