Service Bulletin SB-0039

Subject: Stick Shaker Harness Routing Improvement

ATA-Code: 31-20

Affected Model(s): E1000, E1000GX

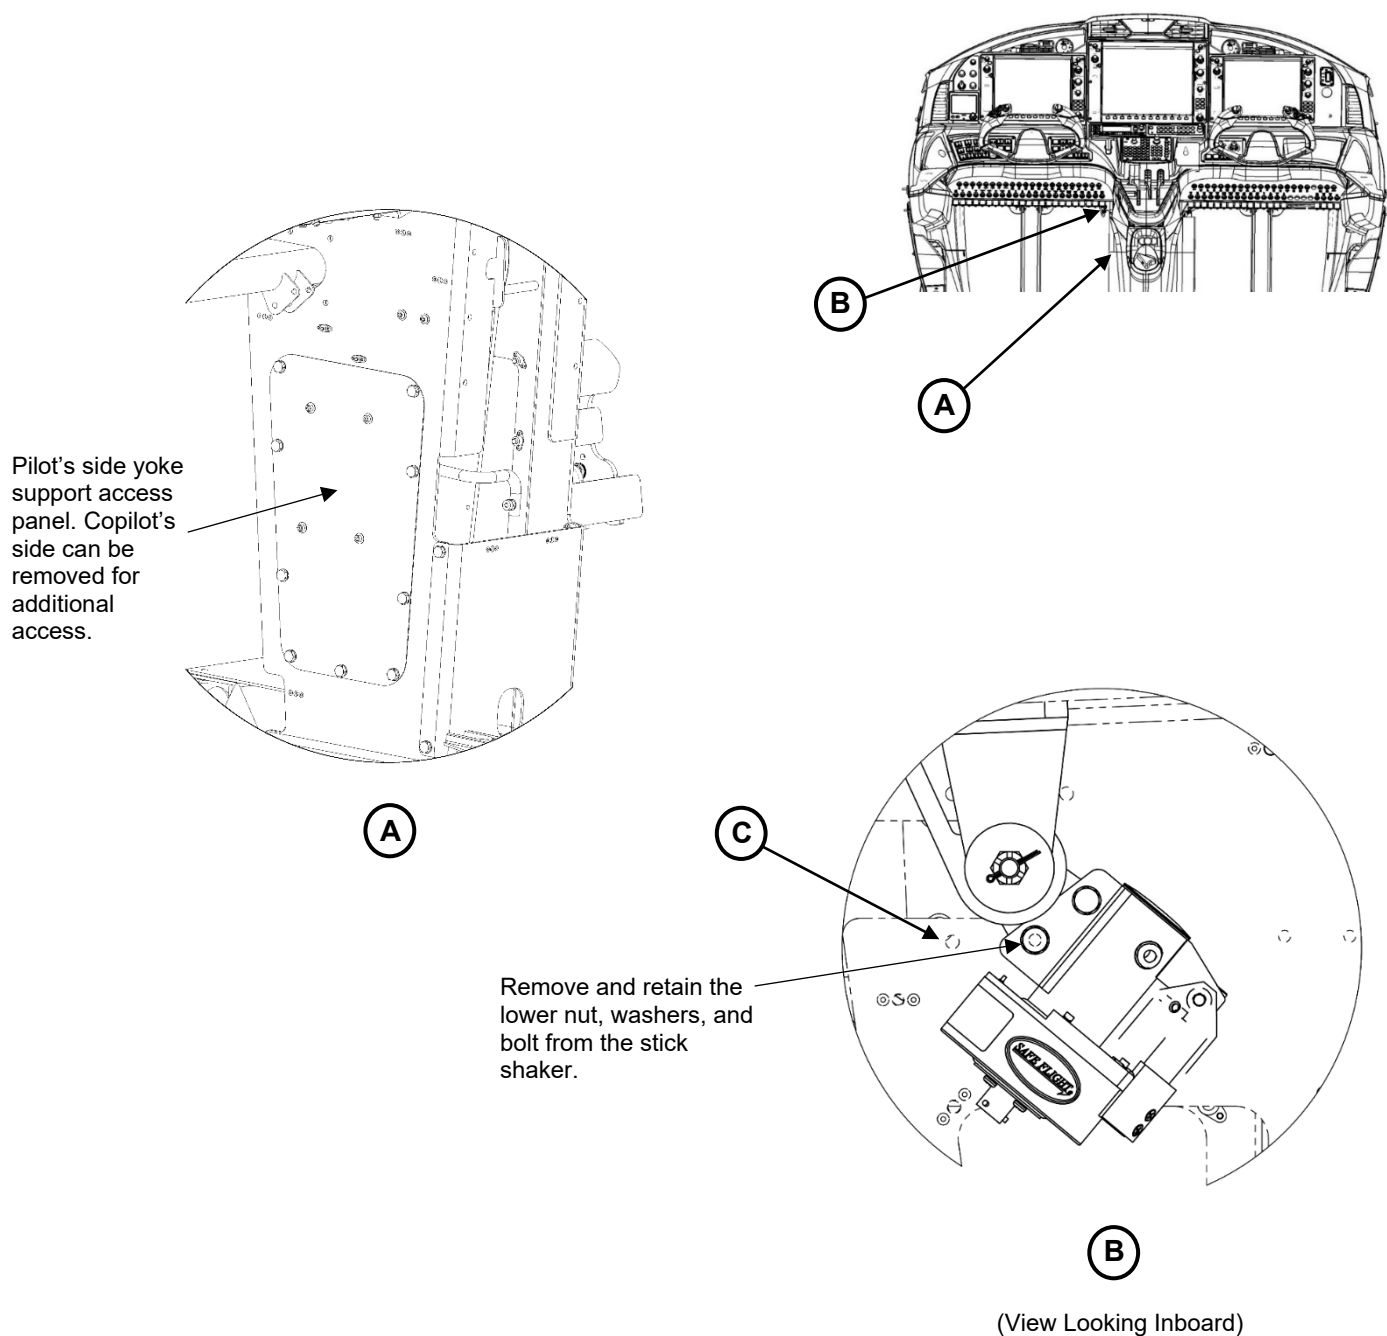
Figure 1: Stick Shaker Harness Routing Improvement (Sheet 1 of 2)

It has been found on affected aircraft that the stick shaker harness electrical connector (P241) may loosen or become damaged due to the forward and aft motion of the yoke.

1. Set the BATT 1 and BATT 2 switches to OFF.
2. Disconnect external electrical power from the airplane (refer to Epic E1000 Aircraft Maintenance Manual, PN SK05000000, chapter 24-40).
3. Remove the pilot seat (refer to Epic E1000 Aircraft Maintenance Manual, PN SK05000000, chapter 25-10).
4. Remove the pedestal finish panel (refer to Epic E1000 Aircraft Maintenance Manual, PN SK05000000, chapter 25-10).
5. Remove the pilot's side yoke support access panel (refer to Figure 1, Sheet 1).

- d. Solder the wires in the new 90° connector:
 - i. K3150329C-22 to pin A
 - ii. K3150310A-22N to pin B.
8. Remove the lower nut, washers, and bolt that attach the stick shaker to the elevator torque tube. Retain the hardware (refer to Figure 1, Sheet 1).
