Service Bulletin SB-0043

Subject: Flap Compensation Potentiometer Removal

Affected Model(s): E1000 GX

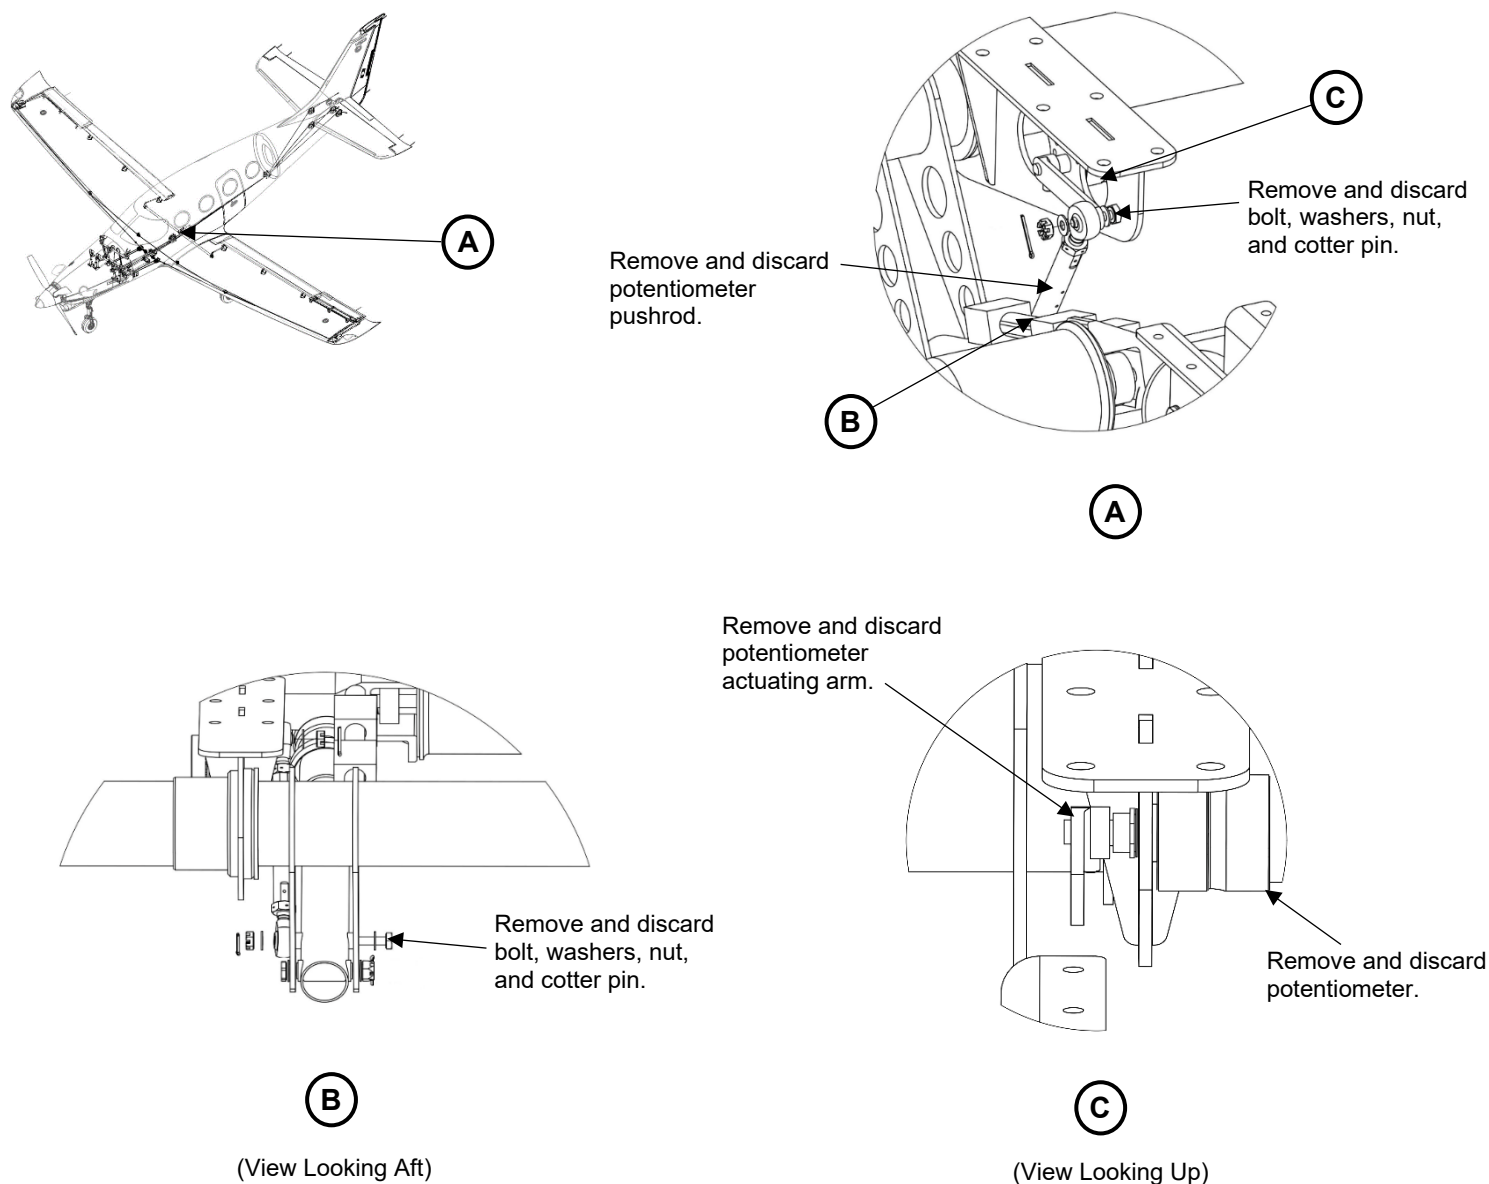
FIGURE 1: Flap Compensation Potentiometer Removal (Sheet 1 of 2)

On affected aircraft the flap potentiometer is not being utilized by the GFC 700 Autopilot and the installation is no longer required.

- a. Disconnect the flap potentiometer electrical connector (J532-P532).
 - b. Remove the cotter pins, nuts, washers, and bolts that attach the potentiometer pushrod to the flap actuator body and the potentiometer actuating arm. Discard the pushrod and hardware.

- c. Loosen the set screw that attaches the actuating arm to the potentiometer. Remove and discard the actuating arm.
 - d. Remove the nut and lockwasher that attach the potentiometer to the flap support bracket. Discard the potentiometer.
