# Service Bulletin SB-0049

**Subject:** Right Bus-Bar Interference

**Affected Model(s):** E1000 GX **Due:** Next annual inspection.

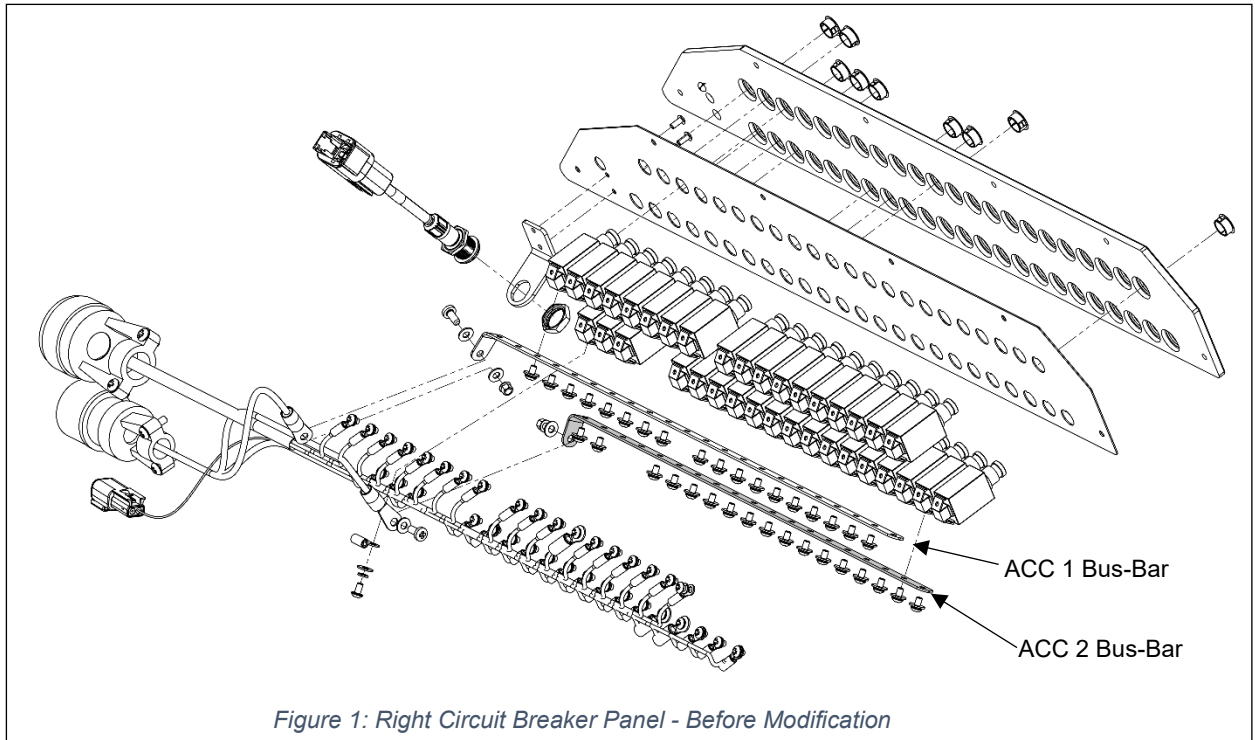
Figure 1: Right Circuit Breaker Panel - Before Modification

On affected aircraft, it has been found that ACC 1 and ACC 2 in the right-hand circuit breaker panel may have fitment issues as designed.

5. Gain access to the right circuit breaker panel ACC 2 bus-bar (refer to Figure 1).
  - a. Remove right hand circuit breaker cover.

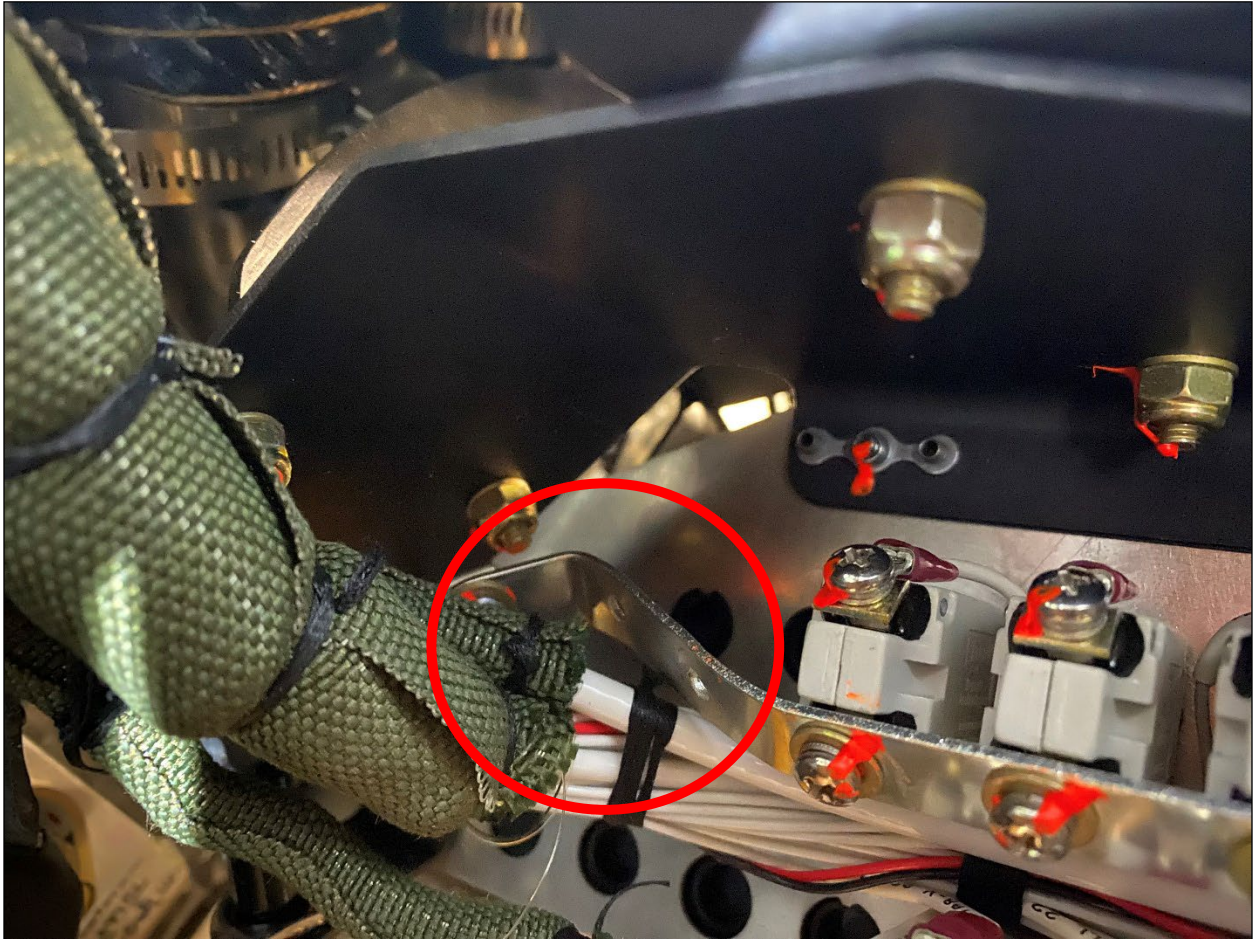
*Figure 5: Damage Location and Example.*

15. Inspect ACC 1 bus-bar, if unaffected, proceed to step 24 (see Figure 5 for example of damage).
16. Remove the screw, washers, and nut that attach the K2460109C-8 wire to the ACC 1 bus-bar tab. Discard the hardware.

19. Remove the ACC 1 bus-bar from the right circuit breaker panel.
20. Modify the ACC 1 bus-bar as follows (refer to Figure 2 and Figure 3):

- a. Remove the 90° tab from the ACC 1 bus-bar.
  - b. Put a 0.20" radius on the modified end of the bus-bar.
  - c. Apply solder to the reworked end of the bus-bar for corrosion protection.
