Service Instruction SI-0013

Subject: Rudder Trailing Edge Damage Repair

Effectivity: K003

Affected Model(s): E1000

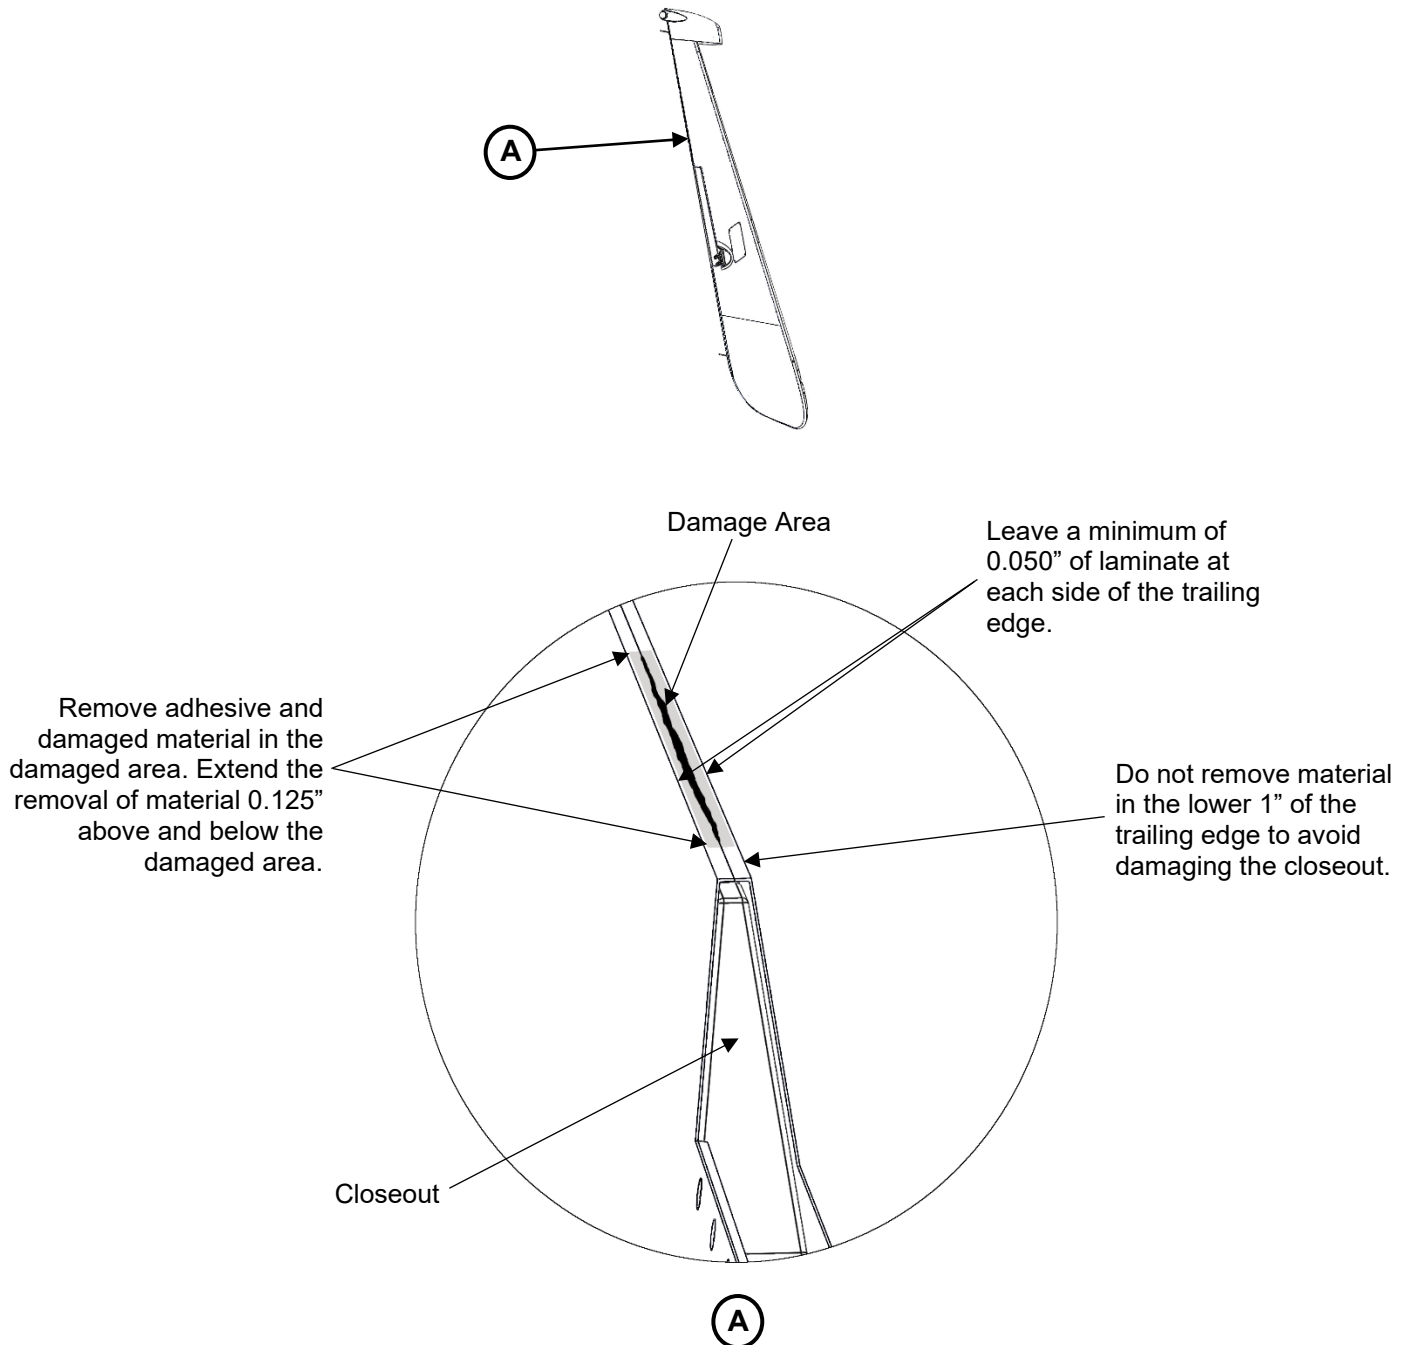
Figure 1: Rudder Repair

During an inspection approximately 6" of the trailing edge of the rudder, just above the trim tab, was found to have a crack at the bond seam location and indications on the painted surface of contact with another object. This Service Instruction gives procedures to repair the damage.

1. Set the BATT 1 and BATT 2 switches to OFF.
2. Remove all external electrical power from the airplane (refer to Epic E1000 Aircraft Maintenance Manual, PN SK05000000, chapter 24-40).
3. Remove the rudder (refer to Epic E1000 Aircraft Maintenance Manual, PN SK05000000, chapter 55-40).
4. Place the rudder on a suitable work surface.
5. Remove the paint from the damaged area (refer to Figure 1).
6. Trim the laminate from the trailing edge to expose the discrepant area, leaving 0.050" of laminate on each side of the trailing edge.

7. Carefully remove the adhesive and damaged material in the discrepant area. Adhesive removal is to extend 0.125" above and below the discrepant area until all damaged material is removed.
8. Tap test the area surrounding the repair to make sure the damage has been removed.
9. Clean and surface prep the repair region as follows:
 - a. Wash the surface with isopropyl alcohol.
 - b. Abrade the surface with 80 - 150 grit sandpaper.
 - c. Remove abrading dust with a vacuum before dry-wiping the surface with a clean, dry, lint-free cloth.

10. Mix Loctite EA 9360 Aero bonding paste with cotton flock filler at a ratio of 8% by weight.

11. Within 30 minutes of step 10, wet out the surface of repair region using neat EA 9360 Aero Bonding paste. Apply paste in a thin layer on the remnant adhesive and exposed laminate in the repair region.
12. Within 30 min of step (10), completely fill the repair region with the bonding paste-cotton flock mix.

- a. Cure for 24 hours at room temperature, or
- b. Cure by applying an air temperature ramp from ambient to 95 deg F at a max rate of 3 deg per minute. Once 95 deg is reached maintain air temperature at 95 deg +/- 5 deg for 120 minutes before allowing to cool.

- a. Apply air temperature ramp from ambient (100°F or lower) to 160±10°F at a max rate of 5°F per minute.
- b. Maintain the air temperature at 160±10°F for a minimum of 90 minutes.
- c. Cool down the air temperature to 110°F or lower at a max rate of 5°F per minute before allowing to cool.
