**Subject:** K028 Cracked Paint Repair

**ATA-Code:** 51-20

**Affected Model(s):** E1000 GX

# Service Instruction SI-0029

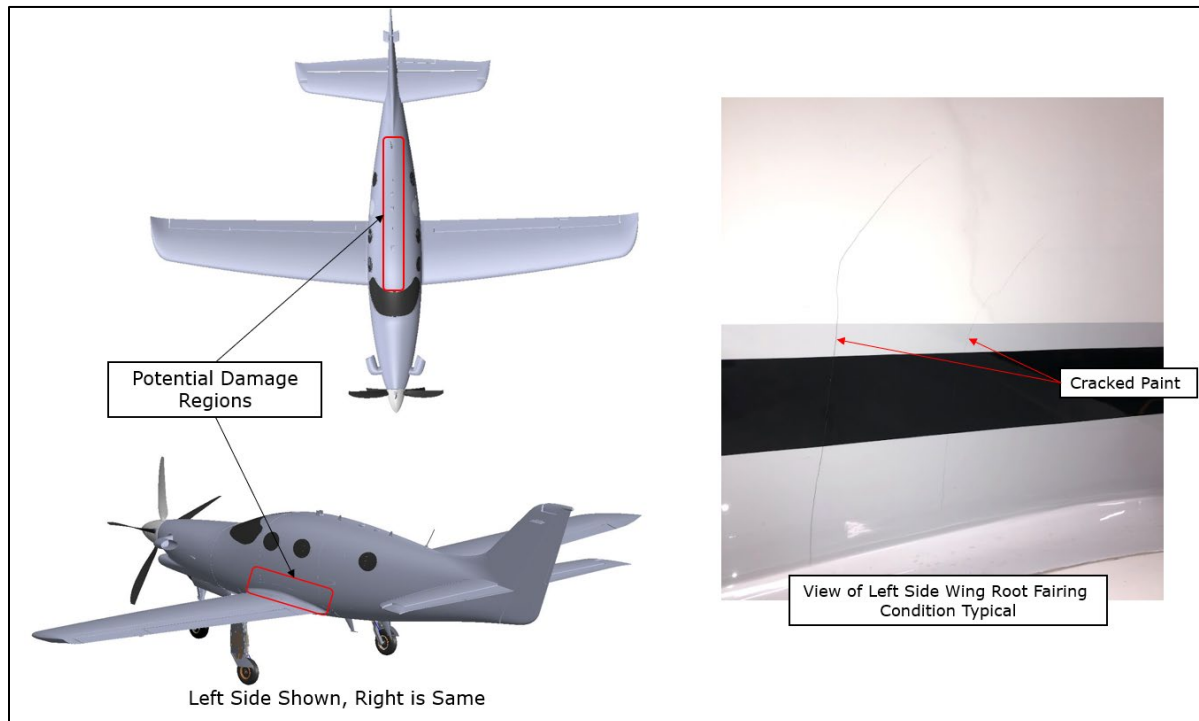
**Figure 1: Damaged Region and Condition**

Recent inspection of the K028 Fuselage found paint cracking in the regions surrounding the wing fairing, in addition to the top bond seam of the fuselage. This cracking is believed to be caused by excessive body work in high displacement areas and is limited to the paint system without affecting the underlying carbon substrate.

1. Set the BATT 1 and BATT 2 switches to OFF.
2. Remove all external electrical power from the airplane (refer to Epic E1000 Aircraft Maintenance Manual, PN SK05000000, chapter 24-40).
3. In any region exhibiting cracked paint, sand to remove all damaged body work. Material removal region is to extend 0.25" +/- 0.125" all around the crack and shall extend to the underlying composite.
