Service Instruction SI-0037

Subject: K027 Wing Tip Leading Edge Repair

Effectivity: K027

Affected Model(s): E1000 GX etc.

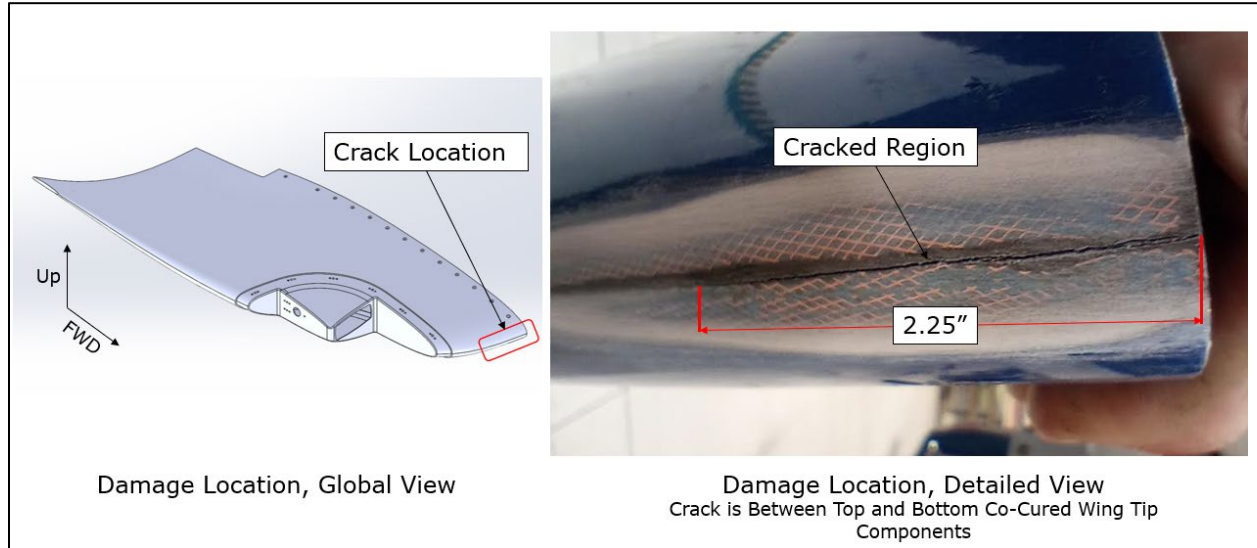
Recent annual inspection of the Right-Hand Wing Tip on Serial Number K027 found a cracked region on the leading edge approximately 2.25" long as shown in Figure 1.

It should be noted that the crack is between the Top and Bottom Co-Cured Wing Tip components and is isolated to the resin matrix without affecting the laminate. Further, the three carbon BID plies which span the top and bottom components on the IML Surface are unaffected by the damaged condition.

Figure 1: Damage Location and Condition

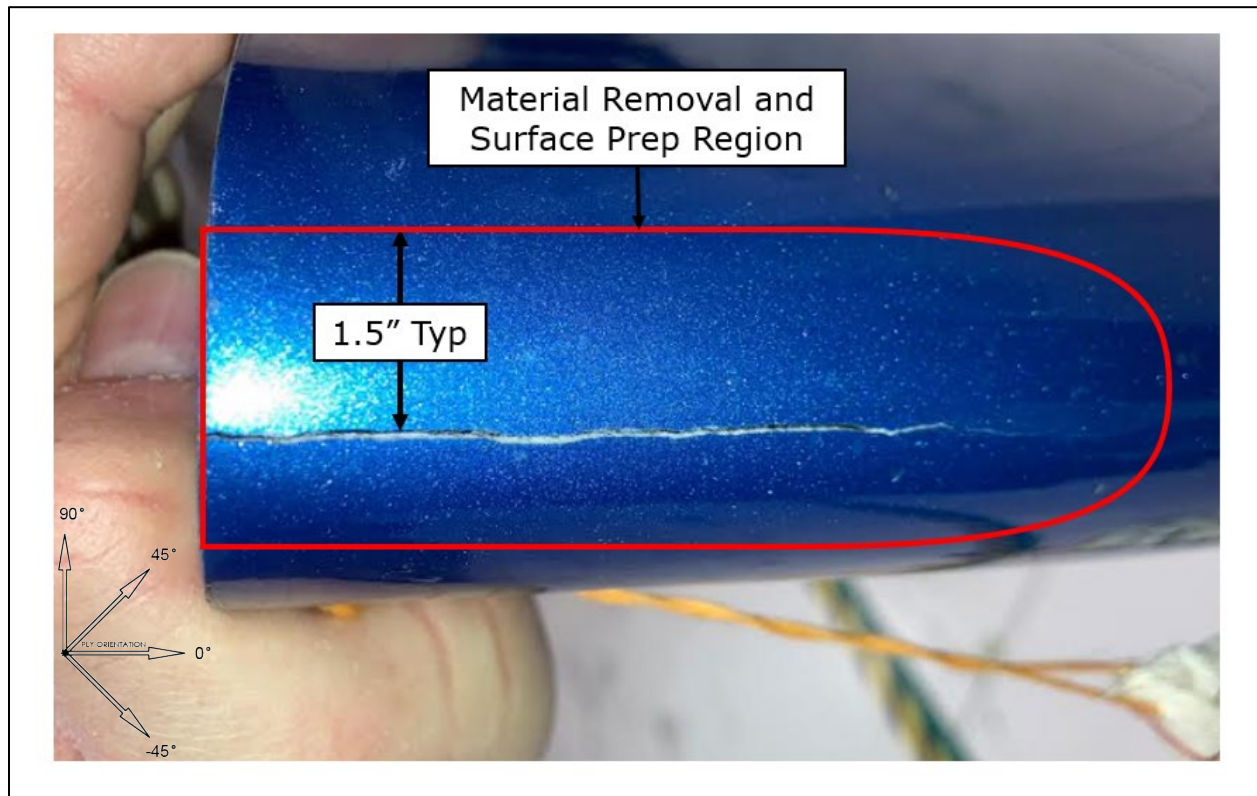
Figure 2: Material Removal and Surface Prep Detail

4. Sand to remove paint, body work, and LSP Protection for a minimum of 1.5" all around the cracked region. See Figure 2 for location. Take care not to damage underlying laminate during material removal.

5. Clean and Surface Prep the material removal region as described below:
 - a. Wash the surface with isopropyl alcohol.
 - b. Abrade the surface with 80 - 150 grit sandpaper.

- c. Remove abrading dust with a vacuum before dry-wiping the surface with a clean, dry, lint-free cloth.
 - d. Final clean the surface by thoroughly wetting the surface with isopropyl alcohol then immediately wiping with a clean, dry, lint-free cloth in a single stroke. After each wipe, turn the drying cloth to a clean surface.
