# Service Letter SL-0008

**Subject:** S-TEC 2100 RNAV Approach Interruption

**Effectivity:** K004-K010

**Affected Model(s):** E1000

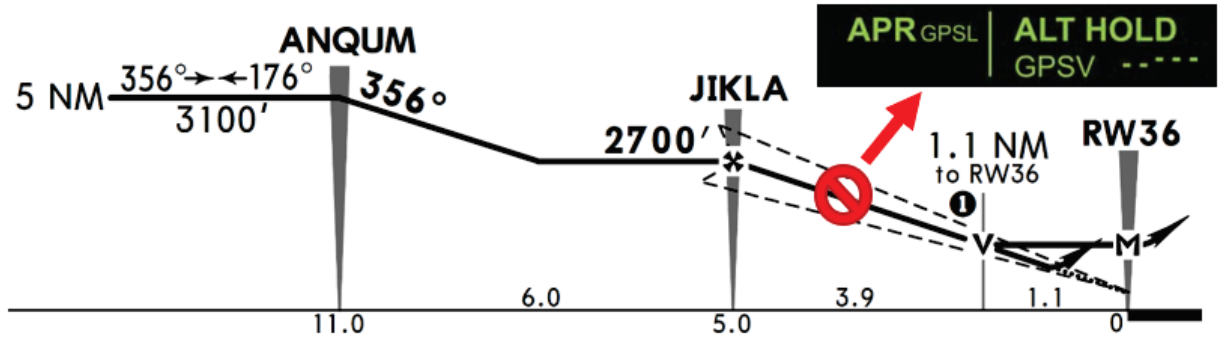
The 2100 DFCS autopilot is designed to fail safe in the event of interrupted navigation signal. If there is an interruption of the glideslope signal when coupled to a glideslope (**GS** mode) or RNAV glidepath (**GP** mode), the DCFS will revert to **ALT HOLD** mode and stop descent.

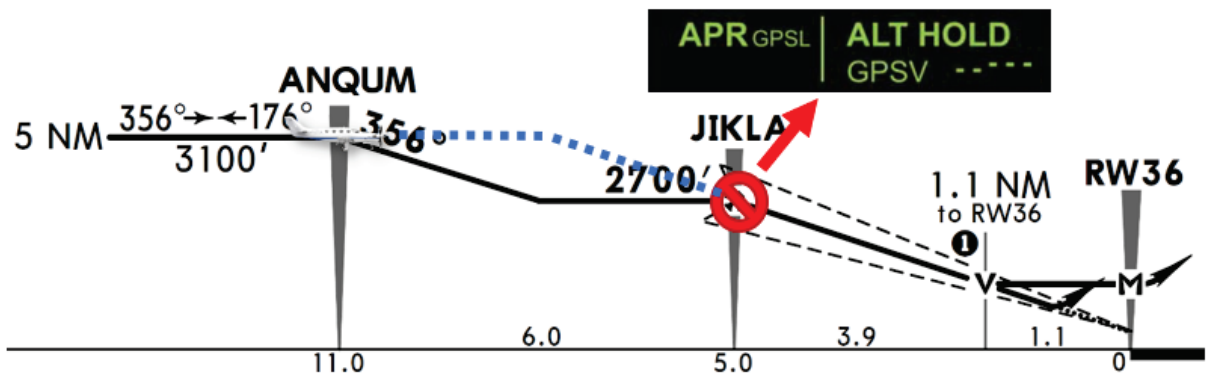
There is a momentary interruption of the vertical navigation signal during waypoint passage caused by the current software installed in the E1000 Classic. For example, the DFCS will enter ALT HOLD mode as it crosses the Final Approach Waypoint (FAWP).

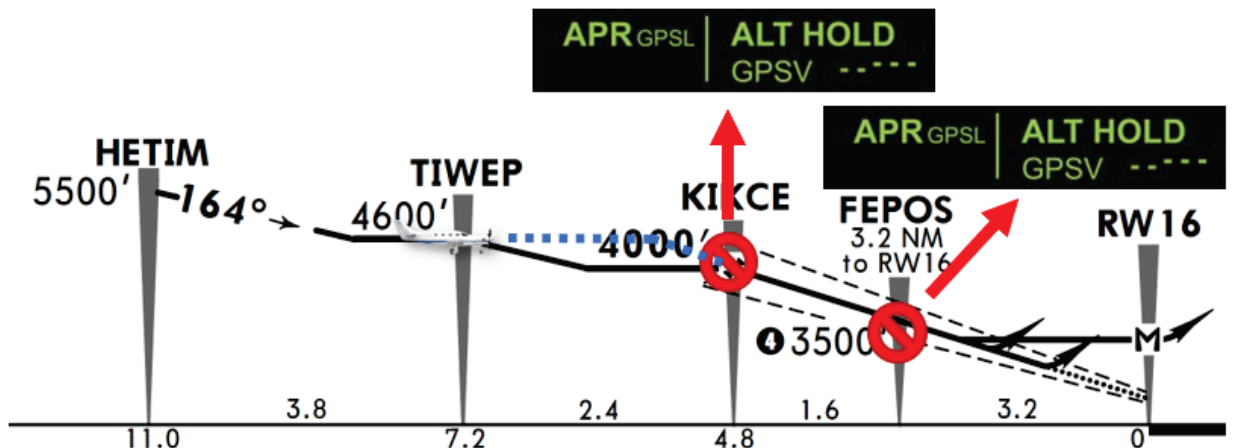
**CAUTION:** The ALT HOLD interruption can occur more than once on approach. If there is a step-down in the procedure, the waypoint passage of the step-down triggers vertical guidance interruption.

**NOTE:** It is imperative the pilot monitors the DFCS mode annunciations during waypoint passage in GPSV mode to determine whether the DFCS successfully re-couples to the glidepath, and to execute the ALT HOLD recovery procedure if it does not.
