# Service Letter SL-0015

**Subject:** Windshield Edge Seal Replacement

**Affected Model(s):** E1000, E1000 GX

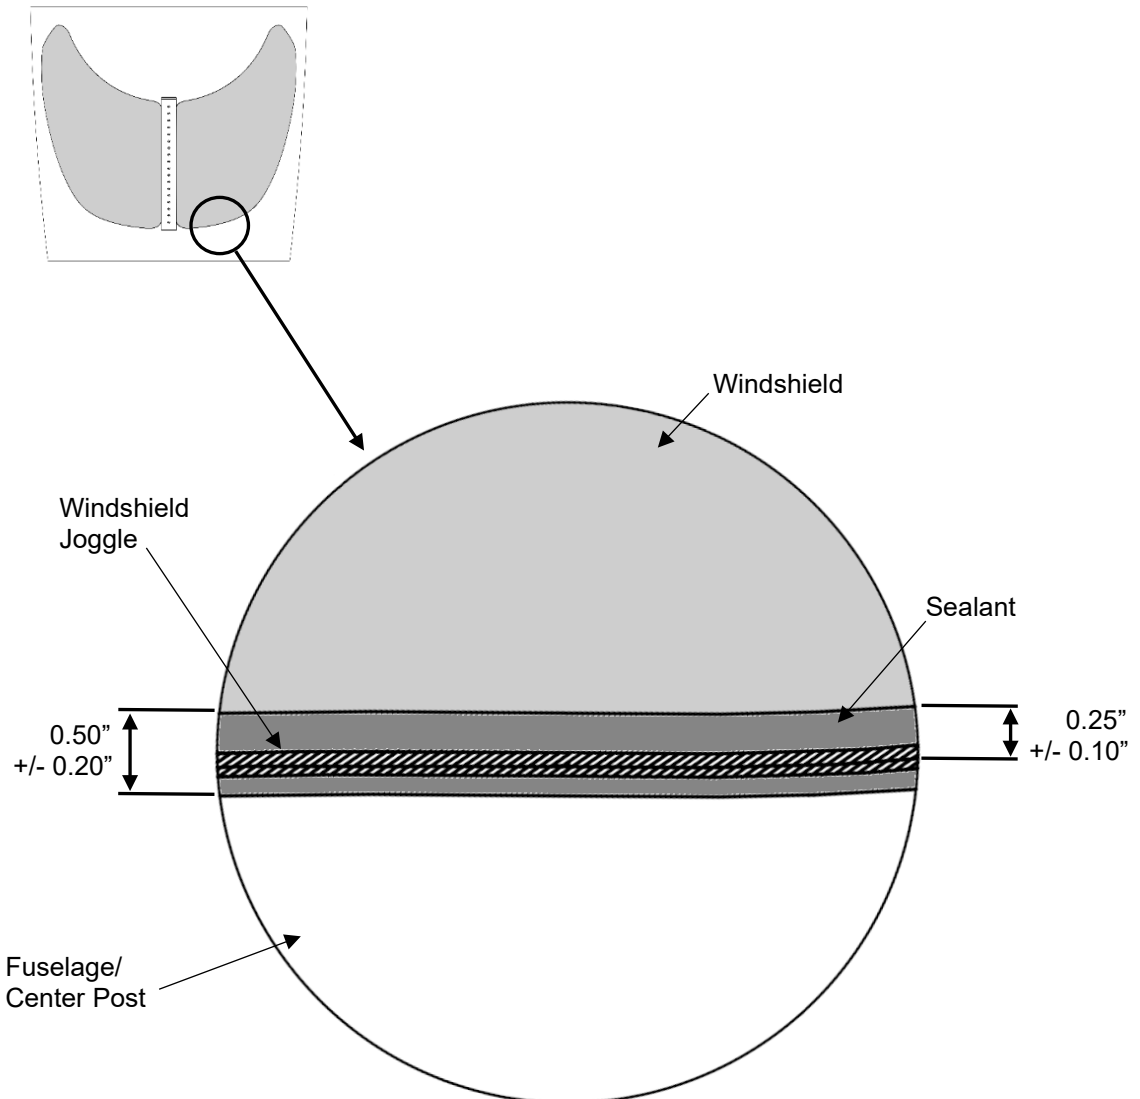
**FIGURE 1: EDGE SEAL DIMENSIONS**

It has been found on affected aircraft that the windshield edge seal may become brittle and deteriorate prematurely.

1. Set the BATT 1 and BATT 2 switches to OFF.
2. Remove external electrical power from the airplane (refer to Epic E1000 Aircraft Maintenance Manual, PN SK05000000, chapter 24-40).
3. Mask the outer perimeter of the windshield and fuselage/center post adjacent to the windshield to protect the work area, refer to Figure 1.

5. Clean the surfaces of the fuselage and windshield to be edge sealed with isopropyl alcohol.
6. Mask both windshields for sealant application as shown in Figure 1.
7. Apply PR-1425 sealant in accordance with the manufacturer's instructions around the full perimeter of both windshields.
8. Smooth the sealant around the perimeter of the windshields (Refer to Figure 2).
9. Remove the mask and allow the sealant to cure in accordance with the manufacturer's instructions.
10. Remove the protective masking from the fuselage and windshield.
