# Service Bulletin SB-0009

**Subject:** Main landing gear damper replacement, clearance inspection, and repair.

**Effectivity:** K003-K006

**Affected Model(s):** E1000

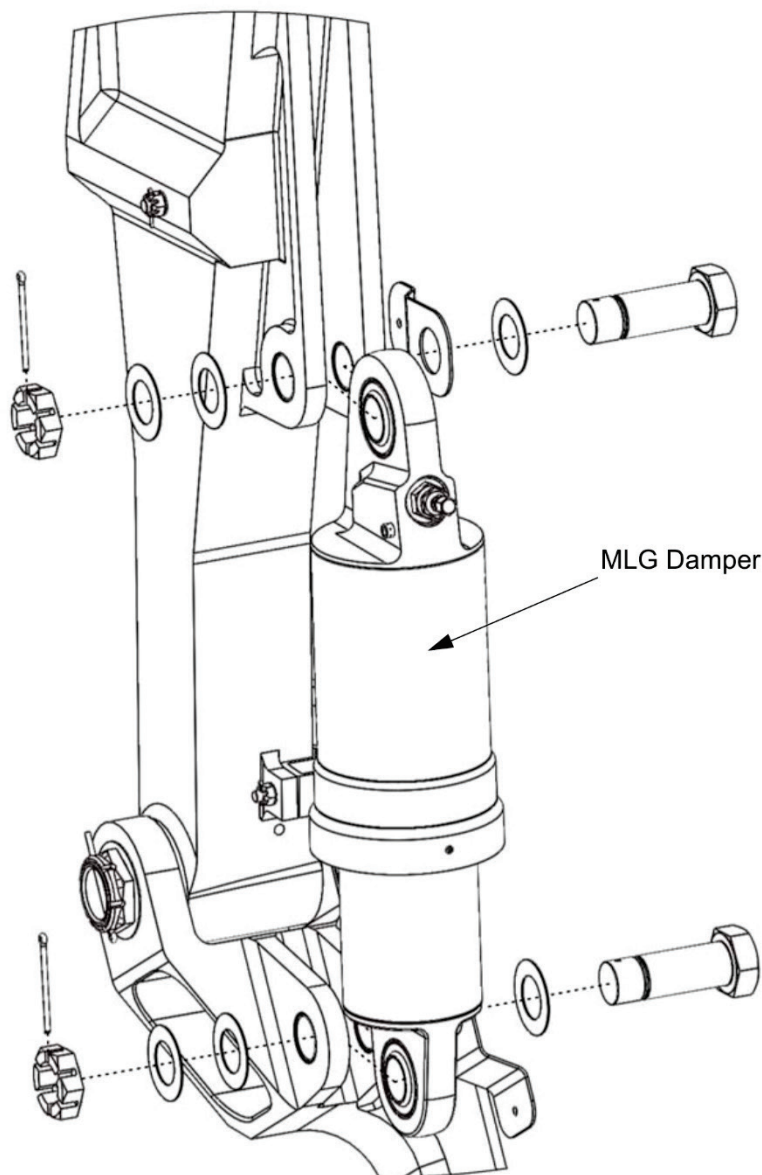
**Figure 1:** Main landing gear damper.

It has been found that some aircraft may not have adequate clearance between the main landing gear damper charging valve and the wheel well liner.

Right side shown, left side opposite.

**E)** Do the operational test of the landing gear system (refer to the E1000 AMM PN SK05000000, chapter 32-30). Make sure the clearance between the damper charging valve and wheel well tunnel liner is at least 0.25”.
