Service Bulletin SB-0031

Subject: Rudder Trailing Edge Bondline Inspection

Effectivity: K003 – K029

Affected Model(s): E1000, E1000 GX

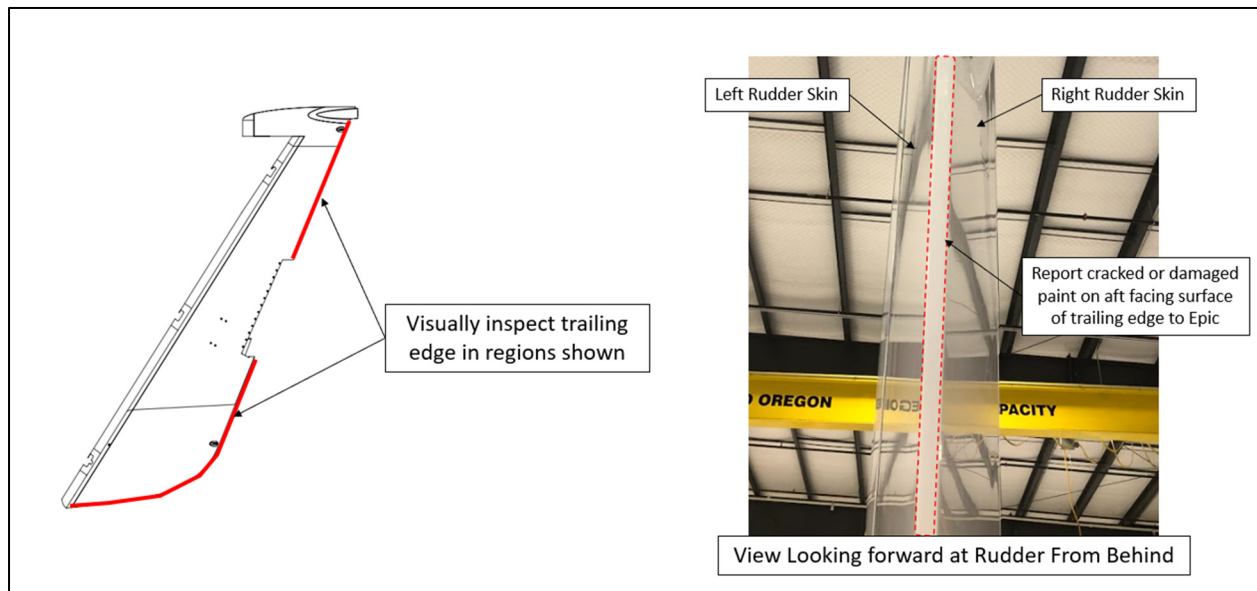
Figure 1: Inspection Region

8 INSTRUCTIONS:

4. If no cracks in the paint are found, make an entry in the maintenance log that steps 7-9 are to be completed at the next annual inspection.
5. If cracks in the paint totaling less than 12" in length are found, do the steps that follow:

6. If cracks in the paint totaling greater than 12" in length are found, proceed to step 7.
7. Perform an ultrasonic inspection of the entire rudder trailing edge bondline as follows:

- a. Prep, prime and touch up paint in the cracked region (refer to Epic E1000Aircraft Maintenance Manual, PN05000000, chapter 51-20).
 - b. Make an entry in the maintenance log that steps 7-9 are to be completed at the next annual inspection.

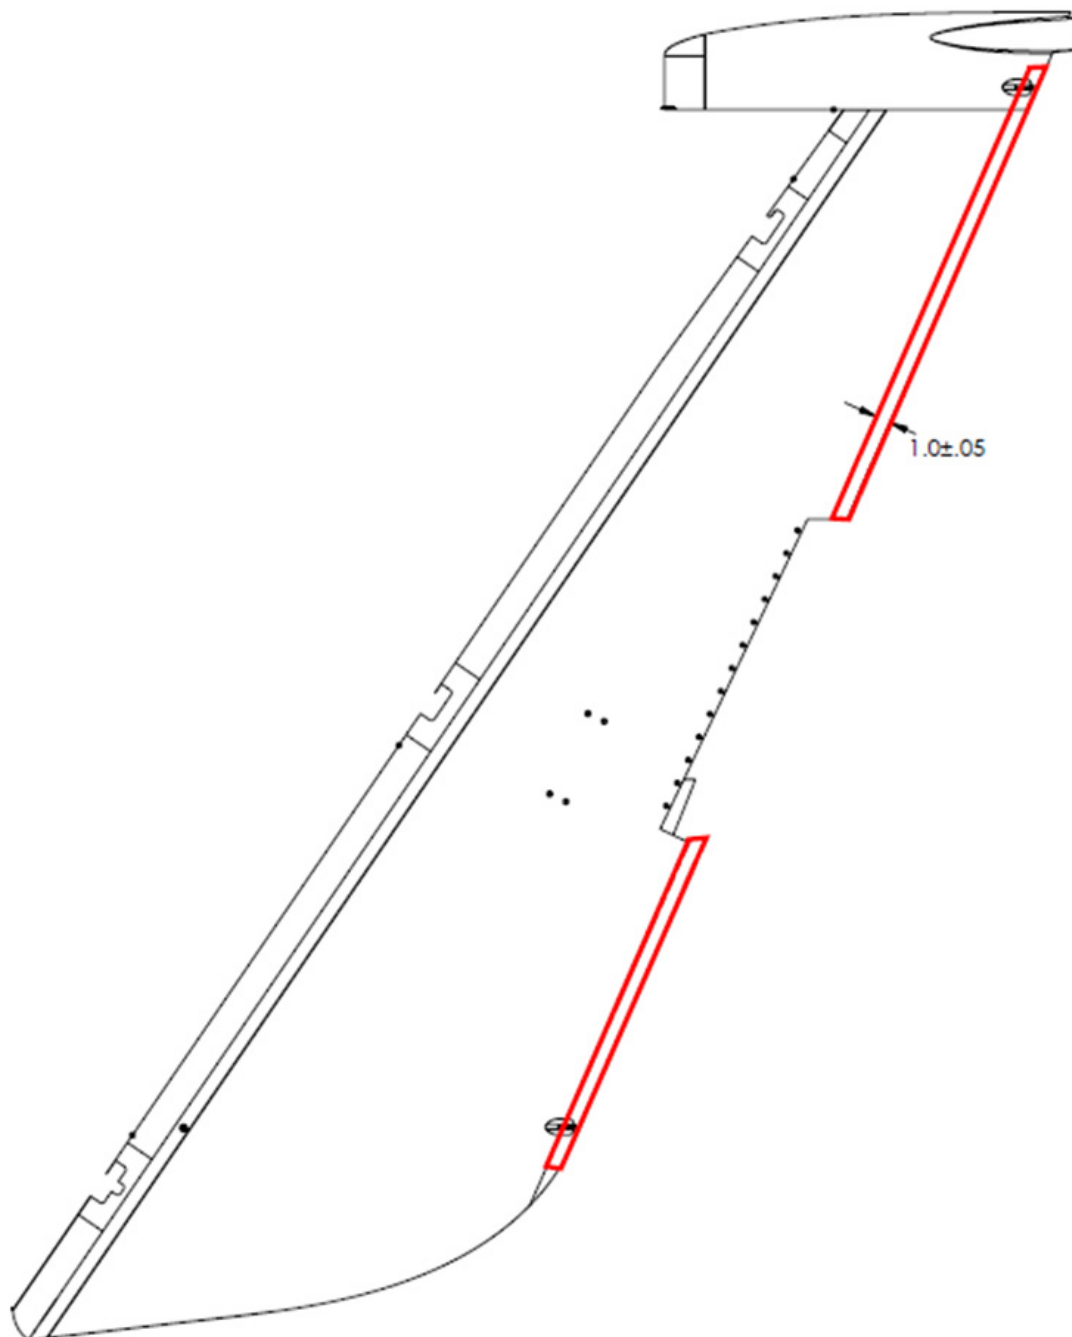
Figure 3: Inspection Area

- a. Locate the bond line on the trailing edge of the rudder, above and below the trim tab cut-out as shown in Figure 3.
- b. Apply couplant or water and place both transducers on either side of the bonded rudder skin and verify signal. Increase gain (dB) until signal reached 80-100% full screen height.

- d. Any loss of signal shall be recorded and evaluated as a relevant indication.
- e. Rejection Criteria: Voids or disbonds 1.0" x 1.0" or greater, spaced 10" or less apart.

9. Report inspection results to Epic, include the location of the cracked paint and results of the tap testing and ultrasonic inspections for disposition :

NOTE: Repair options will be determined by the ultrasonic inspection results. Repair may either be compliance with SB-0036 or an aircraft specific Service Instruction may be issued.
