**Subject:** Rudder Trailing Edge Void Repair

**ATA-Code:** 27-20

**Affected Model(s):** E1000, E1000 GX

# Service Bulletin SB-0036

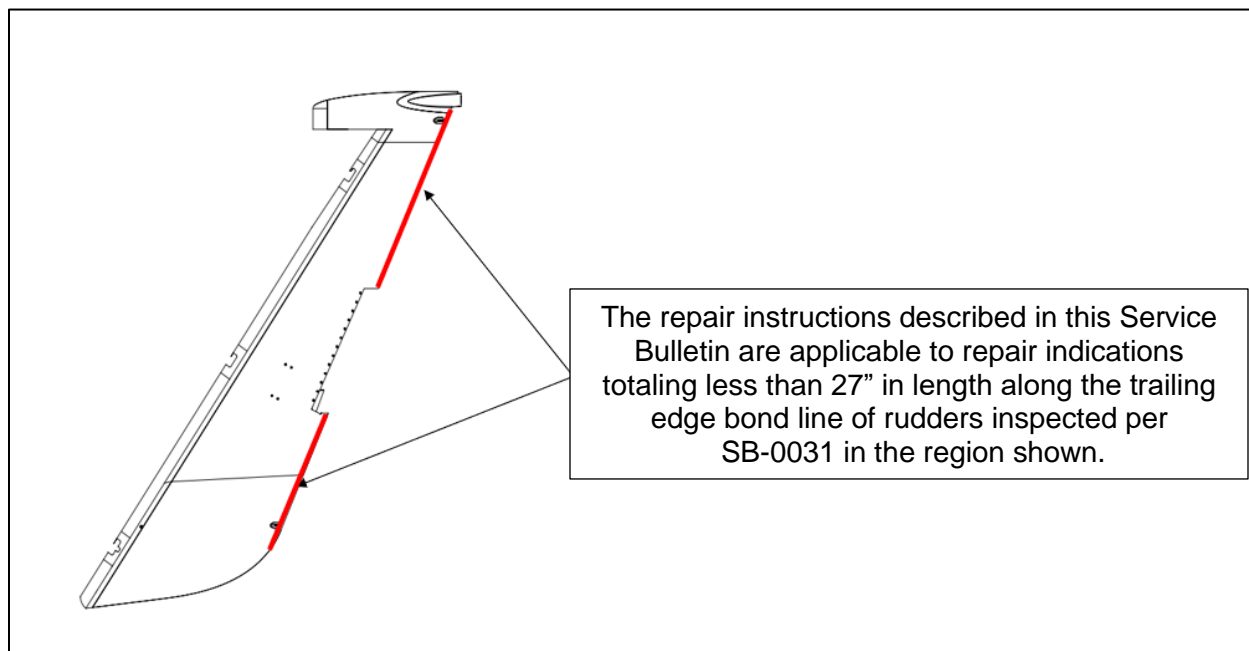
Figure 1: Applicable Region

In accordance with SB-0031, a tap test and ultrasonic inspection is to be completed on the rudder trailing edge bond line of Serial Numbers K003 – K029 among the E1000 Fleet. If the inspection from SB-0031 shows a void totaling less than 27" in length along the bonded joint, comply with this Service Bulletin to repair the void.
