Service Bulletin SB-0044

Subject: Main Landing Gear Protective Plate Placement

Effectivity: K023 – K032

Affected Model(s): E1000GX

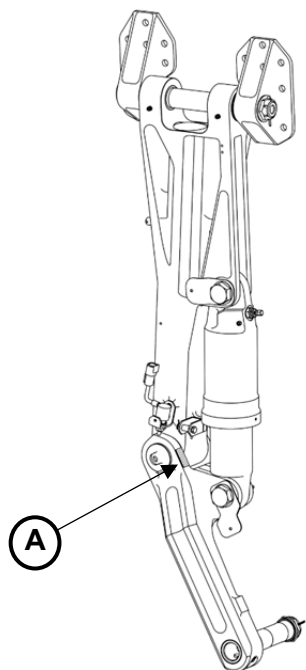
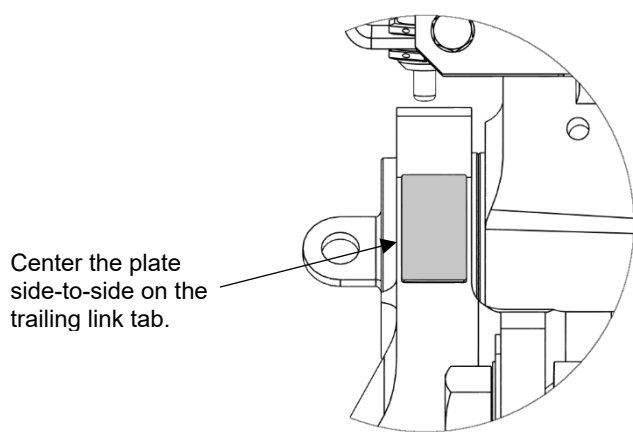
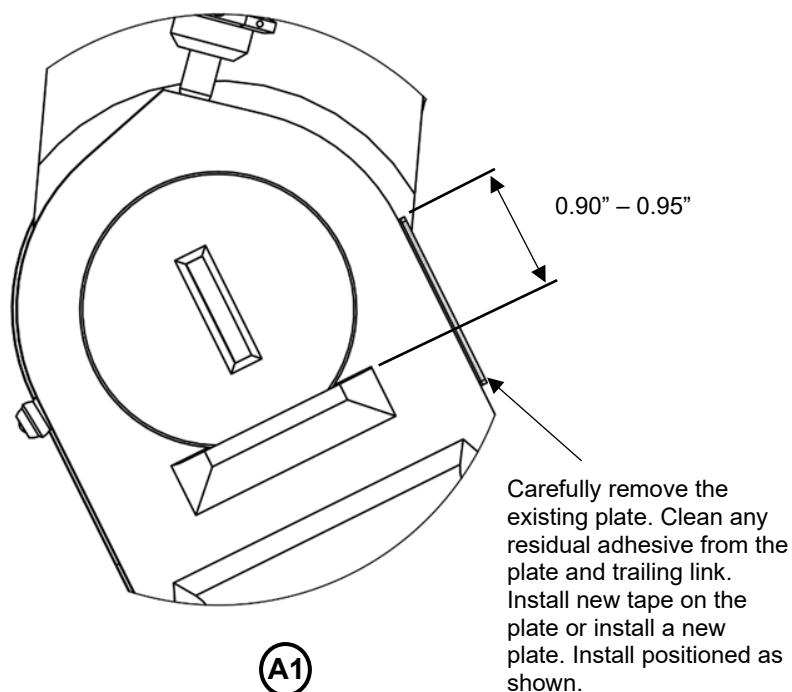
Figure 1: Main Landing Gear Protective Plate Placement

It has been found on effected aircraft that the protective plate installed on the aft face of the main landing gear trailing link inboard tabs may not be correctly positioned. This could allow the up-lock hook to contact the trailing link.

- iii. Prime with Type I, Class C1 or C2 epoxy primer conforming to MIL-PRF-23377.
 - iv. Paint the repaired area (refer to the Epic E1000 Airframe Maintenance Manual, PN SK05000000, Chapter 51-20).
9. If the protective plate was damaged during removal, obtain a new plate, and proceed to step (10). If the protective plate was not damaged during removal, do the steps that follow:
- a. Clean any residual adhesive from the plate with isopropyl alcohol.
 - b. Install new 3M VHB 5915 tape on the plate.
 - c. Clean the installation surface of the trailing link with isopropyl alcohol.
10. Install the plate on the trailing link as shown in Figure 1.

NOTE: Make sure the plate is not on the radius portion of the trailing link.

Center the plate
side-to-side on the
trailing link tab.
