Service Bulletin SB-0051

Subject: Wing Wiring Harness Inspection/Replacement

Effectivity: K003 – K037

Affected Model(s): E1000, E1000 GX

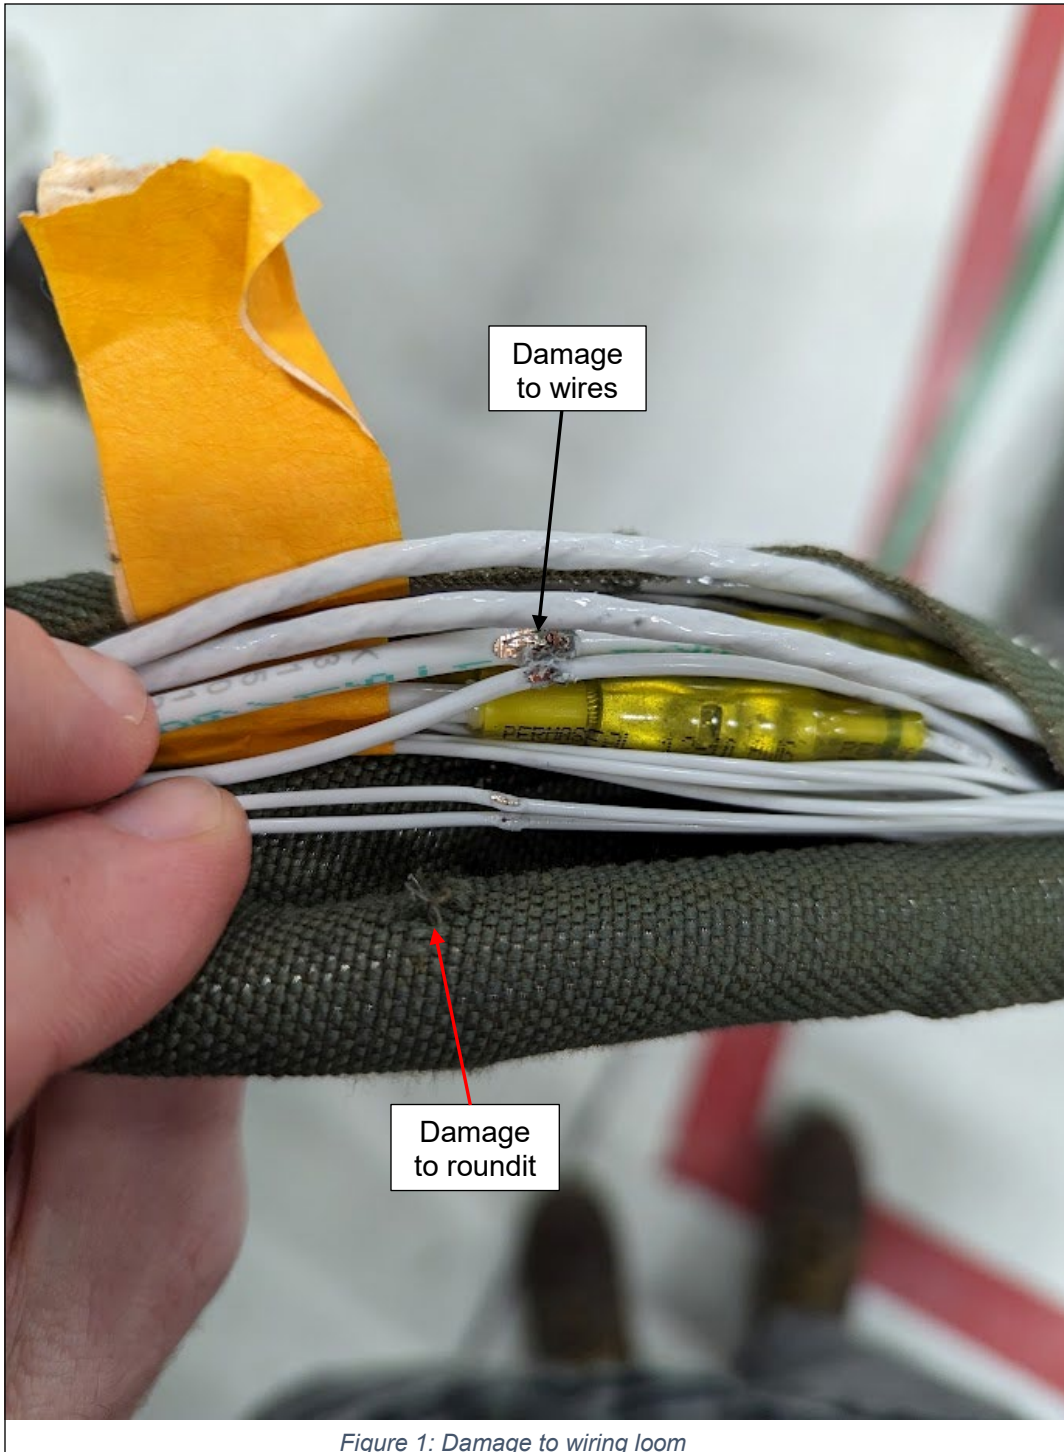
This Service Bulletin has been created to explain how to inspect for possible wiring damage found in wing wiring harness.

Figure 1: Damage to wiring loom

1. Set the BATT 1 and BATT 2 switches to OFF.
2. Disconnect external electrical power from the airplane (refer to the E1000 AMM PN SK05000000, chapter 24-40).
3. Remove pilot and copilot belly panels (refer to the E1000 AMM PN SK05000000, chapter 57-10).
4. Disconnect P148 and P146 connectors, one on each side of the aircraft.
5. Remove inner most leading-edge access panel on pilot side of the wing.
6. Cut the two inner most cable ties.
7. Feed the P148 connector with harness out of the access panel.
8. Cut nylon lacing to uncover the wires beneath the roundit.
9. Inspect wires and roundit for physical damage (see Figure 1 for example, see Figure 2 for location).
 - a. If damage to wire(s) is found, contact Epic for further instructions.
 - b. If no damage is found, continue to step 10.

10. Rewrap wires in roundit and install new lacing.

Note: Lacing must be tied every 3" +/- 1". Roundit must be secured at the ends with either lacing or heat shrink.

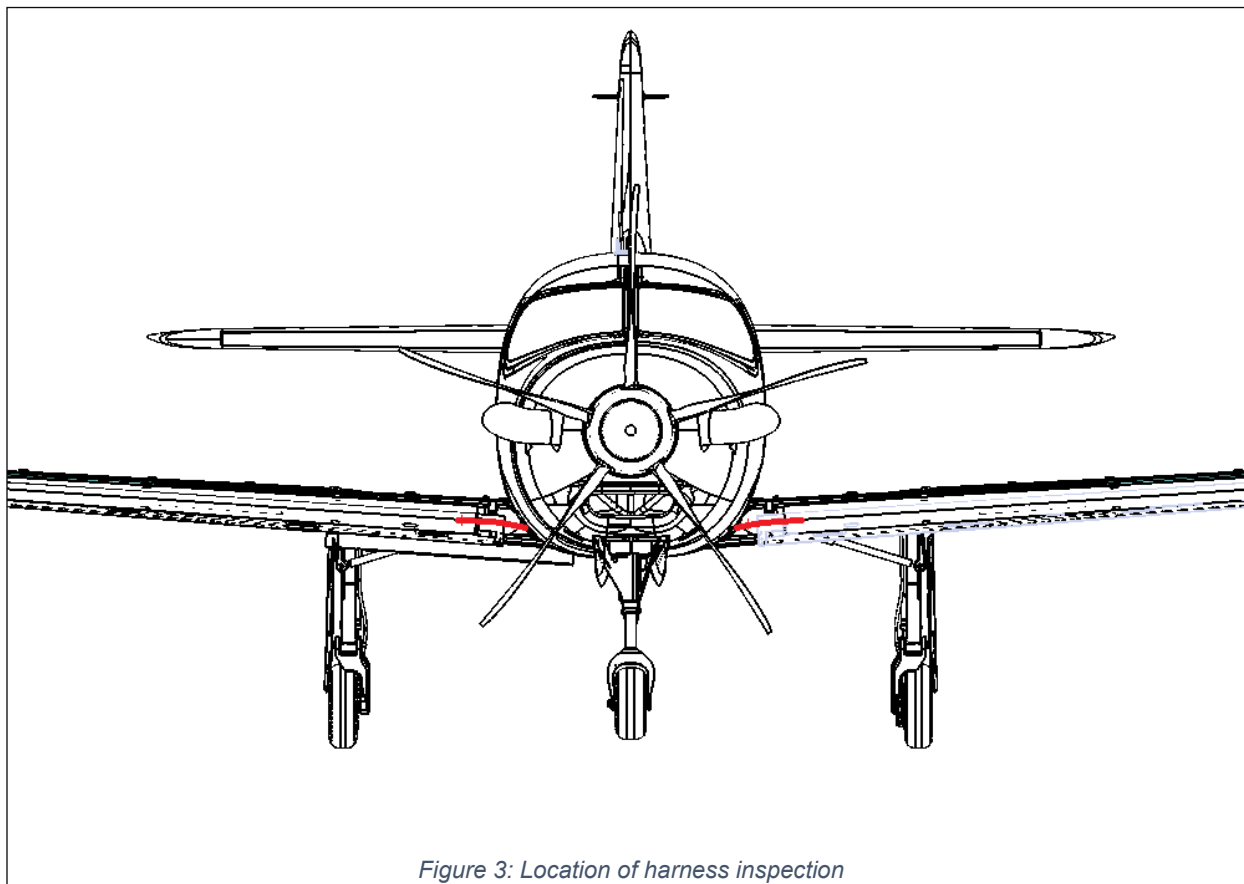
Figure 3: Location of harness inspection
