Service Bulletin SB-0052

Subject: Excessive Bodywork Cracked Paint Repair

Affected Model(s): E1000 GX

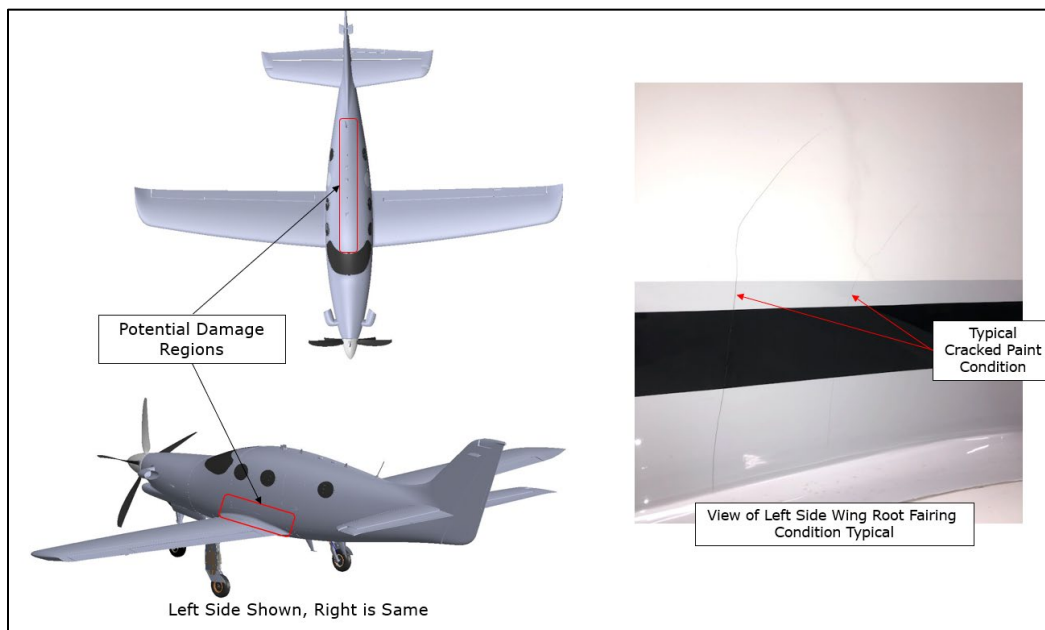
Figure 1: Damaged Region and Condition

Recent inspection of several aircraft in the E1000 Fleet found paint cracking along the fuselage in the regions surrounding the wing fairing, in addition to the top bond seam of the fuselage. This cracking is believed to be caused by excessive body work in high displacement areas and is limited to the paint system without affecting the underlying carbon substrate. This Service Bulletin is applicable for paint cracks of any size in the regions indicated in Figure 1 and are limited to the paint and body work system.

1. Set the BATT 1 and BATT 2 switches to OFF.
2. Remove all external electrical power from the airplane (refer to Epic E1000 Aircraft Maintenance Manual, PN SK05000000, chapter 24-40).
3. In any region exhibiting cracked paint, sand to remove all damaged body work. Material removal region is to extend 0.25" +/- 0.125" all around the crack and shall extend to the underlying composite.
