Subject: Emergency Door Rigging Inspection

ATA-Code: 52-20

Affected Model(s): E1000, E1000 GX Due: As soon as practical

The purpose of this Service Bulletin is to verify proper installation and function of Emergency door escape latch.

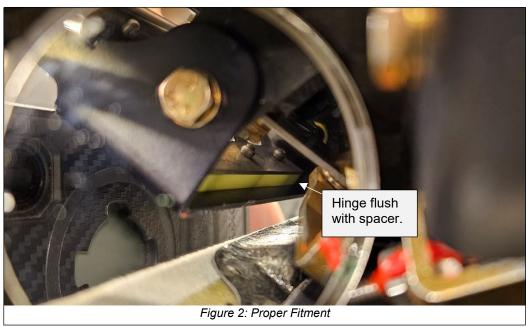
- 1. Remove emergency door handle access panel.
- 2. Using an inspection mirror inspect the hinge for damage and correct installation as follows:
 - a. Make sure the emergency escape top latch hinge (located behind the emergency exit handle) is installed properly and aligns with perimeter of emergency escape hinge spacer as shown in Figure 2.

- b. Make sure there is no damage of any kind to the hinge, including but not limited to: cracks, bending or distortion of the hinge plates, or loose or missing rivets.
