# Service Letter SL-0008

**Subject:** S-TEC 2100 RNAV Approach Interruption

**Effectivity:** K004-K010

**Affected Model(s):** E1000

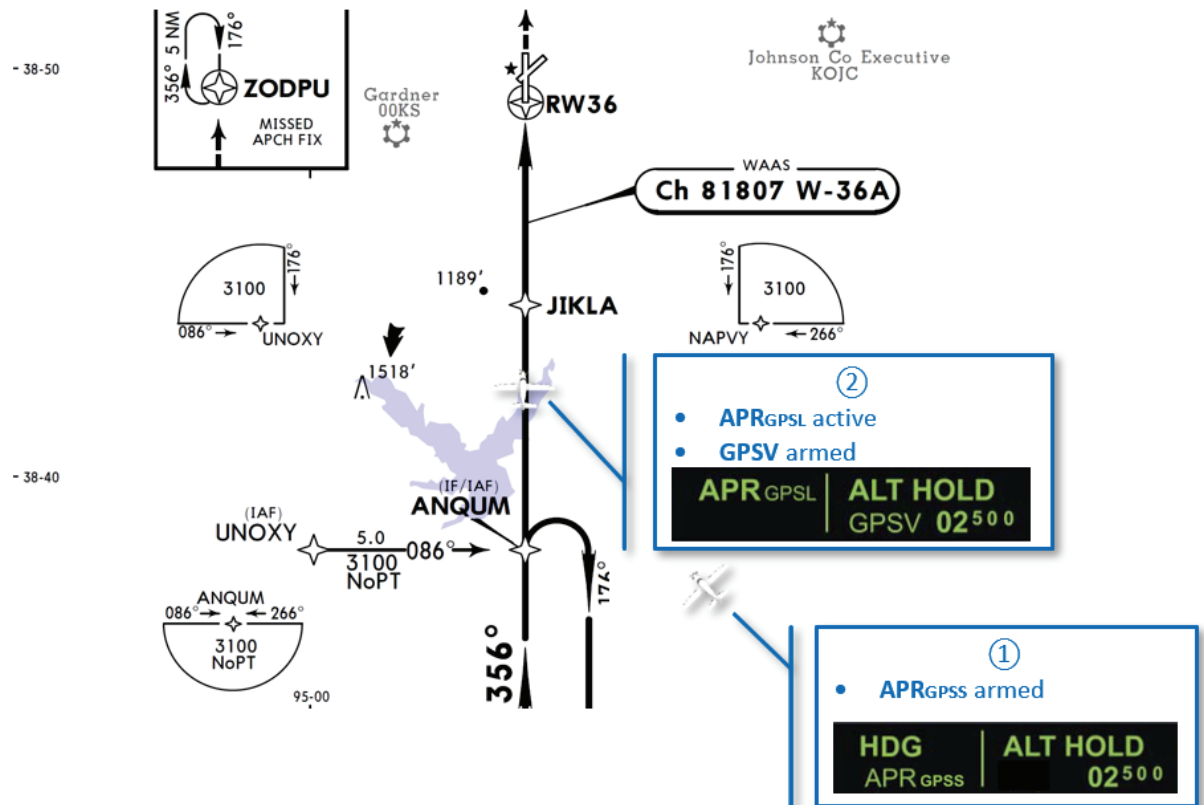
When coupled to an RNAV approach with vertical guidance is **APR<sub>GPSL</sub>** (GPS lateral) and **GPSV** (GPS vertical).
