Service Bulletin SB-0031

Subject: Rudder Trailing Edge Bondline Inspection

Effectivity: K003 – K029

Affected Model(s): E1000, E1000 GX

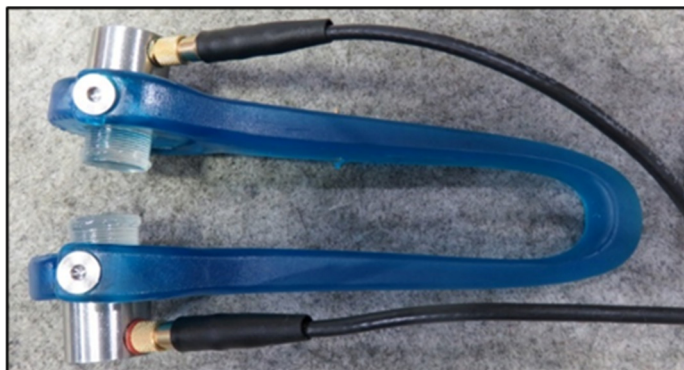
Figure 4: Alignment Tool

NOTE: The alignment tool (Figure 4) should be used whenever possible, except for any non-parallel surfaces (e.g., the bottom of the rudder trailing edge).
