Subject: Emergency Door Rigging Inspection

ATA-Code: 52-20

Affected Model(s): E1000, E1000 GX Due: As soon as practical

The purpose of this Service Bulletin is to verify proper installation and function of Emergency door escape latch.

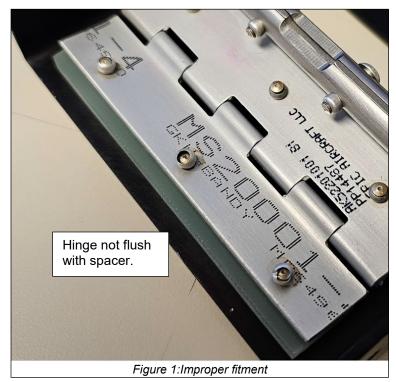
- 1. Remove emergency door handle access panel.
- 2. Using an inspection mirror inspect the hinge for damage and correct installation as follows:
 - a. Make sure the emergency escape top latch hinge (located behind the emergency exit handle) is installed properly and aligns with perimeter of emergency escape hinge spacer as shown in Figure 2.

- b. Make sure there is no damage of any kind to the hinge, including but not limited to: cracks, bending or distortion of the hinge plates, or loose or missing rivets.

- c. If any damage is found, and/or the hinge is not installed correctly, proceed to step 3.
 - d. If no damage is found and the hinge is installed correctly, proceed to step 4.

- a. Repair/replace as follows:
 - i. If there is any damage to the hinge, replace the hinge with a new AK52201001 assembly.
 - ii. If handle rivets are loose, remove and replace with CR3213-4-06.
