Service Instruction SI-0006

Subject: Stall Computer Tuning Procedures

Effectivity: K007

Affected Model(s): E1000

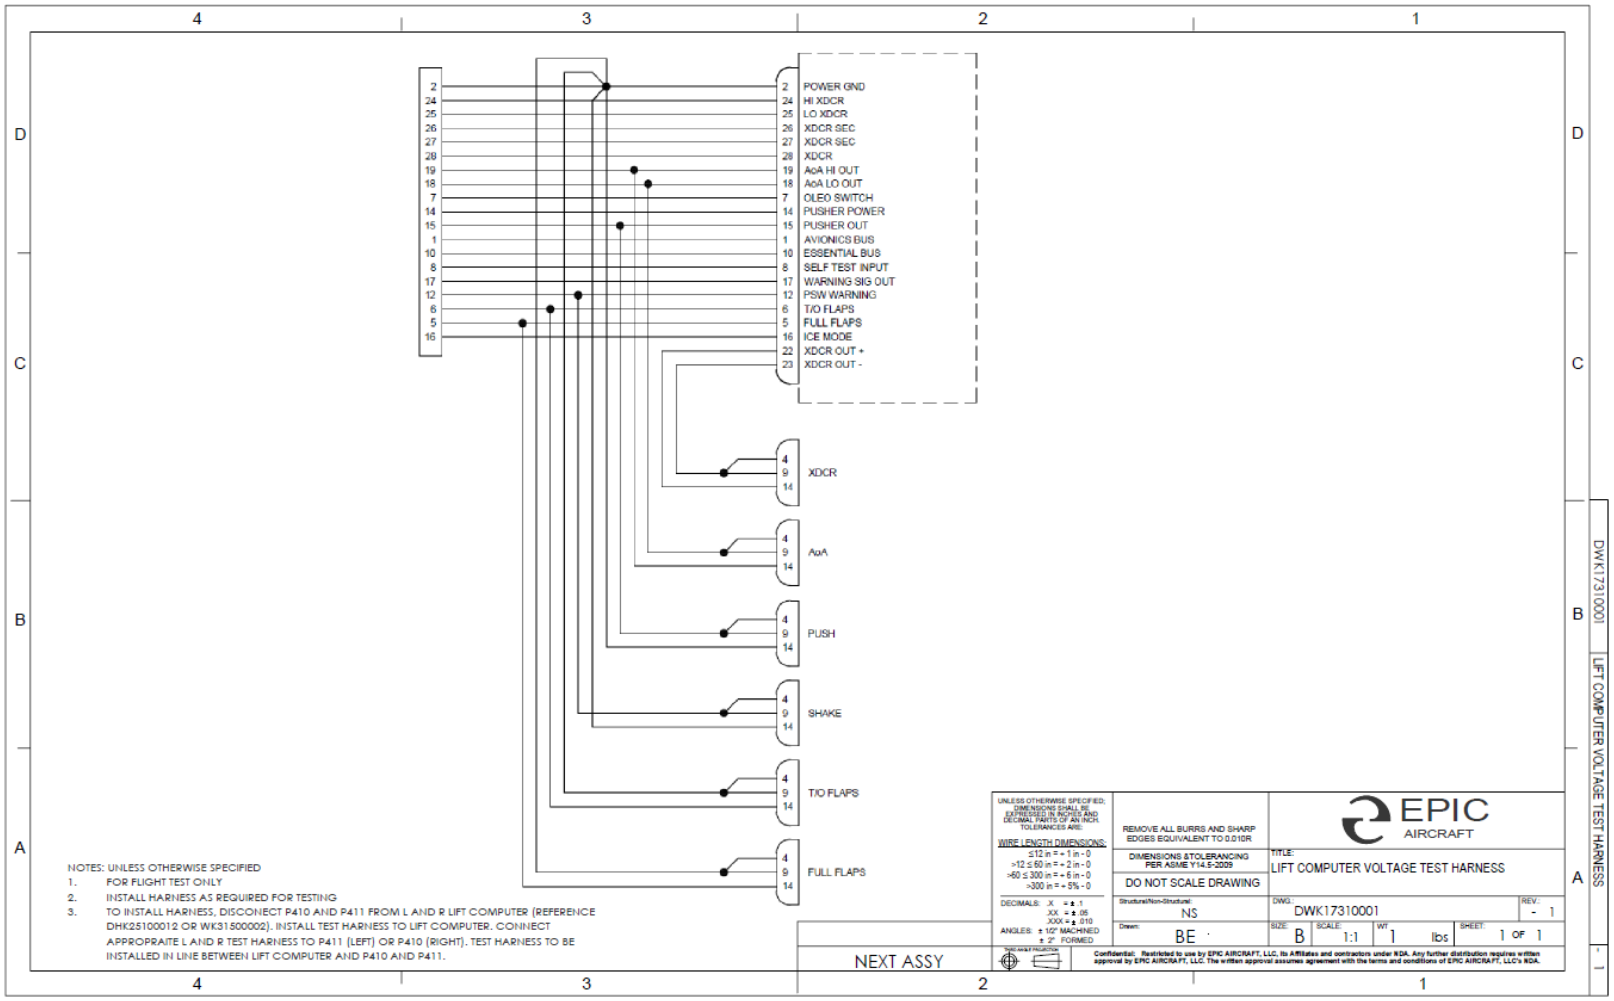
Test Setup
For the following tests, it will be necessary to install the Lift Computer Voltage Test Harness as described in the previous figure. Gain access to the stall computers under the passenger floor in accordance with the Airframe Maintenance Manual.
